#### A multidiscipline 35 kV cable failure investigation

ORTON H., FURST G. & BATHO A., International Consulting Engineers, Vancouver, Canada

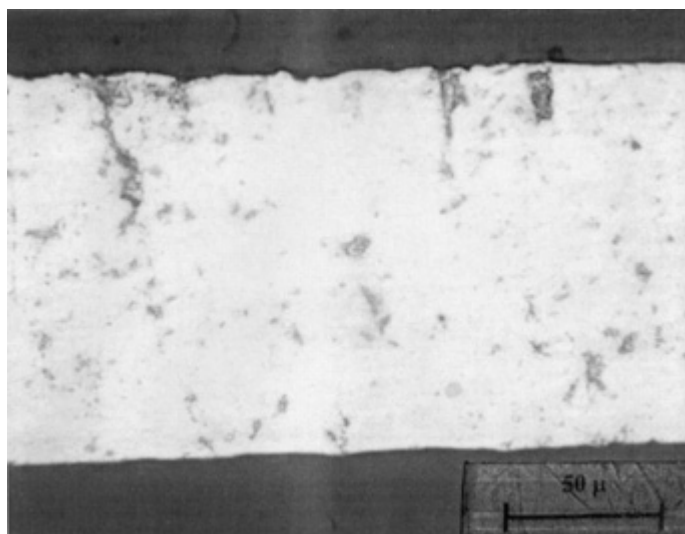
Figure 1: Microstructure of the edge of copper tape sample showing tramp elements and oxide inclusions (Mag: 500X)

- Tramp elements and oxide inclusions appeared at localized areas along the edge of the copper tape of the failed cable (Figure 1). These defects reduced the tape's tensile strength and elongation.
- Bending and pulling the cable through a sharp radius can easily wrinkle the copper tape of the failed cable. Certain parts of the cable can be exposed to an excess of 3000 lbs of load when the cable catches around the sharp bend. When the edge of

the copper tape that contains the defect is caught in this way, the copper tape will fracture due to mechanical overload.

Hence, it is concluded that the fracture of the copper tape of the cable took place due to a combination of the defect on its edge and an abnormal bending operation. It appears that these two factors individually would not fracture the copper tape.
