# INVESTIGATION OF THE AGING CHARACTERISTICS OF CST TERMINATION MADE OF SILICONE RUBBER AT CONTAMINATION AREA

Tatsuya NAKAMURA, Chubu Electric Power Co. Inc., JAPAN, Nakamura.Tatsuya@chuden.co.jp  
 Yoshihide KOZASA, Chubu Electric Power Co. Inc., JAPAN, Kozasa.Yoshihide@chuden.co.jp  
 Akiyoshi SATO, Chubu Electric Power Co. Inc., JAPAN, Akiyoshi.Satou@chuden.co.jp  
 Taikichi KONDOH, Chubu Electric Power Co. Inc., JAPAN, Kondou.Taikichi@chuden.co.jp  
 Masao OHTSUBO, Sumitomo 3M Ltd., JAPAN, mohtsubo1@mmm.com

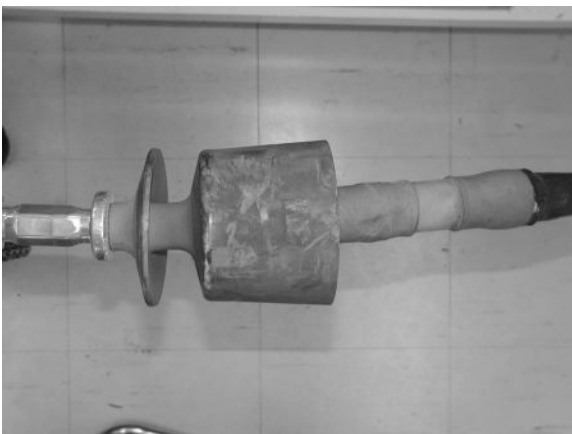
**Figure 4: Appearance of the termination**

Appearance was observed visually. The surface of the termination was dirty in some degree. However, the defect like the crack or tracking was not observed.

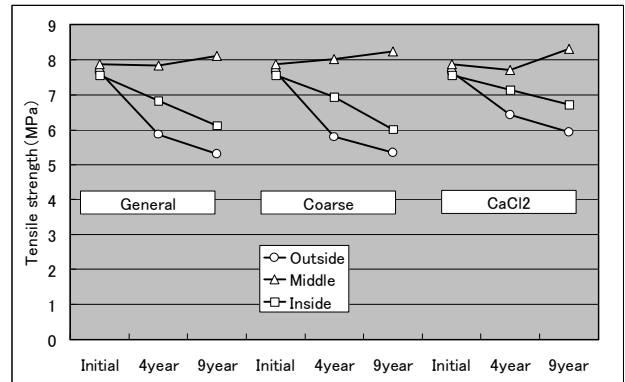
**Figure 6: Tensile strength**

In the middle portion, there was little degradation. But in outside and inside portions, the degradation tendency of tensile strength and elongation were observed. However, it doesn't become a problem on practical use.

In insulator material analysis (tensile strength, elongation), the slightly degradation tendency was observed. It is thought that there is an influence such as ozone because the tendency is seen at the inside which is not being exposed to sunlight.

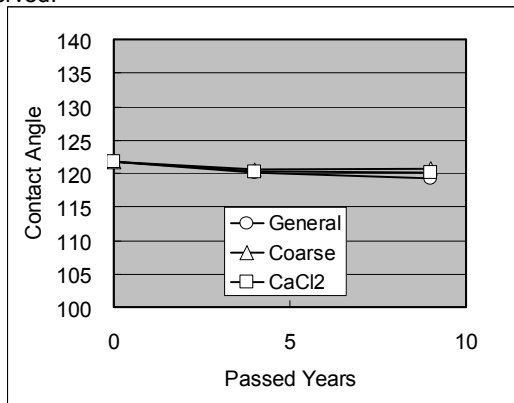
**Figure 8: Contact angle**

Hydrophobicity is one of the features of silicone rubber. It was confirmed by measuring the water-drop contact angle. Consequently, any change on the hydrophobicity was not observed.

The hydrophobicity of the surface of the field exposed insulator was equivalent to initial one and maintains high value. It was verified that high hydrophobicity of silicone rubber is maintained for a long period.

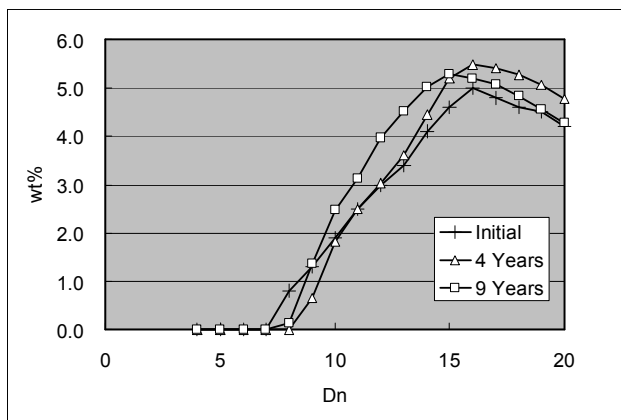
**Figure 9: Low molecular weight siloxane**

Consequently, siloxane increased in number in the range of the degrees 10-20 of polymerization, and it is presumed

that softening degradation is progressing somewhat.

In the hardness measurement, softening tendencies have been observed. Moreover, by the quantitative analysis of low molecular weight siloxane, the tendency that polymer becomes to low molecule was observed. Therefore, it is thought that the softening degradation progresses on the surface of silicone rubber.

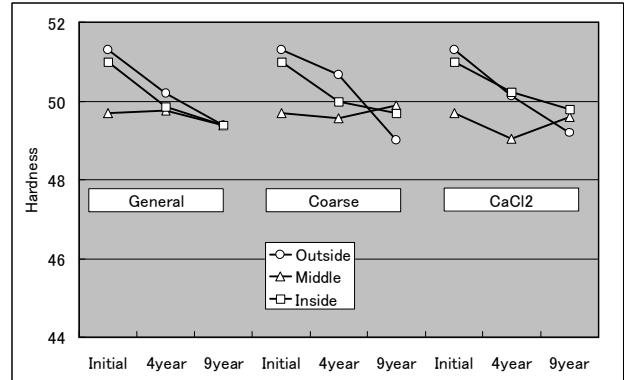
**Figure 10: Hardness**

As same as the quantitative analysis of low molecular weight siloxane, hardness of the silicone rubber was measured in order to presume the softening degradation during field exposure. As a result, some tendencies to soften were observed.

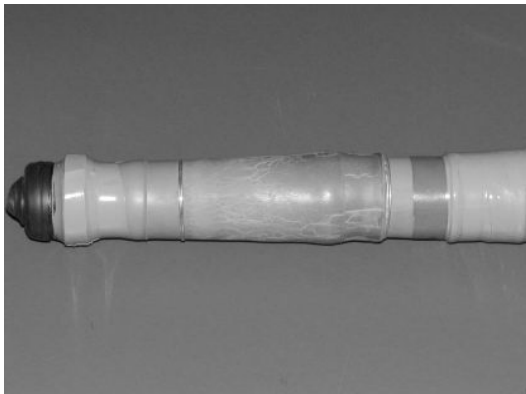
**Figure 12: Test sample after tracking resistance test**

Tracking resistance of the field exposed termination was evaluated by JIS C 3005 tracking resistance measurement test method. All samples passed and high tracking resistance performance was verified.

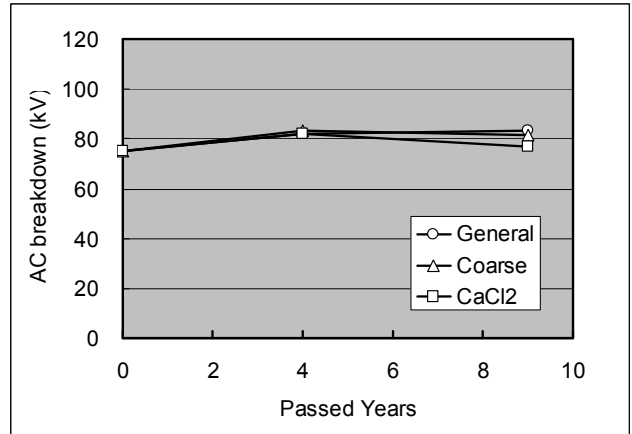
**Figure 13: AC breakdown voltage**

The AC breakdown voltage of the field exposed termination was measured and compared with initial one. All terminations showed sufficient level to the specification value (35kV).

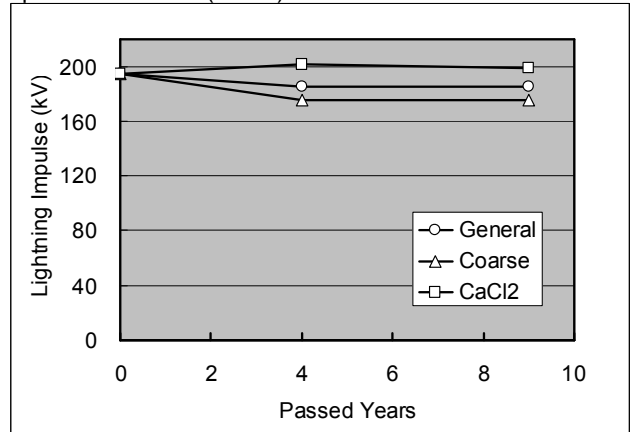
**Figure 14: Lightning impulse breakdown voltage**

The lightning impulse breakdown voltage of the field exposed termination was measured and compared with initial one. All terminations showed sufficient level to the specification value (-95kV).

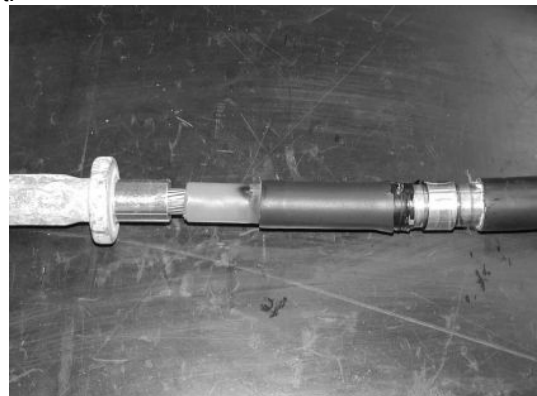
**Figure 15: Appearance of the inside of the termination**

The inside appearance of the termination insulator was investigated after the electric examination. Any water penetration at the terminal portion and the grounding clamp portion was not observed and an initial metallic luster was kept.

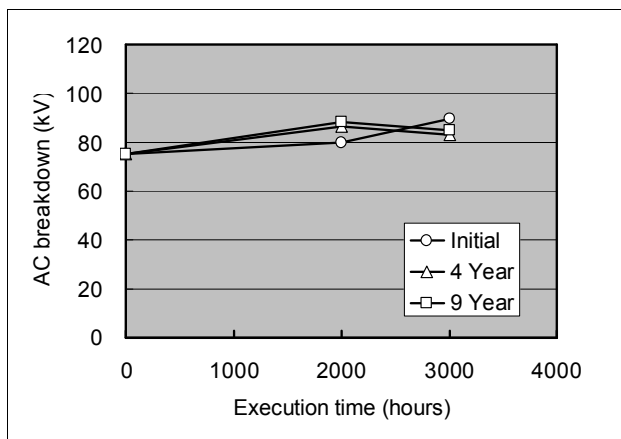
Figure 17: Remaining performance

3M contamination test is an examination method that simulates the dust stain region in an industrial region in the seaside etc. The decrease in the insulation performance of the CST termination was not observed though the accelerated aging test on 3000 hours was done by this method.

We thought that this termination have high insulation performance in spite of the surface contamination because dry band is always secured by bell shape shade.

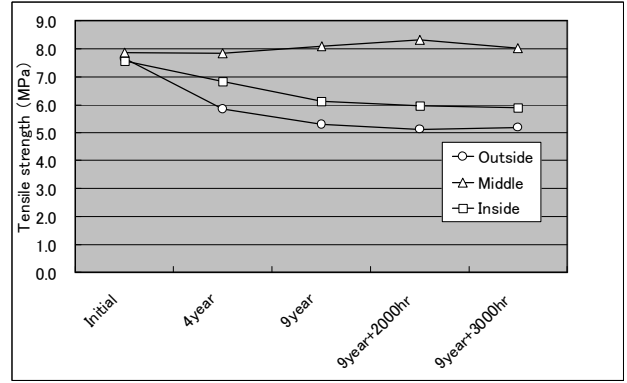
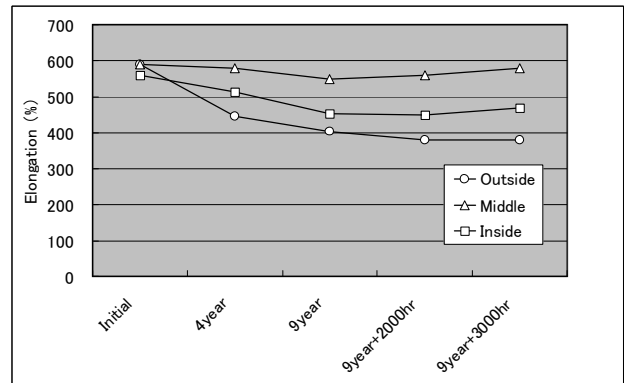
On the other hand, the decrease tendency was seen as for the tensile strength and the elongation of the silicone rubber. However, the degree of the decrease is smaller than in actual field. Therefore, it is thought that the surface contamination that 3M acceleration aging test simulates doesn't influence the physical properties decrease in the silicone so much.
