INITIATION SITE ANALYSIS OF VENTED WATER TREES GROWING FROM THE CONDUCTOR SCREEN OF SERVICE AND LABORATORY AGED XLPE CABLE INSULATION

Sverre HVIDSTEN, SINTEF Energy Research, (Norway), Sverre.Hvidsten@sintef.no
Karl-Michael JÄGER, Borealis AB, (Sweden), Karl-Michael.Jaeger@borealisgroup.com
Annika SMEDBERG, Borealis AB, (Sweden), Annika.Smedberg@borealisgroup.com
Hallvard FAREMO, SINTEF Energy Research, (Norway), Hallvard.Faremo@sintef.no
Ulf H. NILSSON, Borealis AB, (Sweden), Ulf.Nilsson@borealisgroup.com
Stine KVANDE, Norwegian University of Science and Technology, (Norway), Stinekv@stud.ntnu.no
Mildrid SELSJORD SINTEF Energy Research, (Norway), Mildrid.Selsjord@sintef.no
Wilfried KALKNER, Technische Universität Berlin, (Germany), Kalkner@ihs.ee.tu-berlin.de

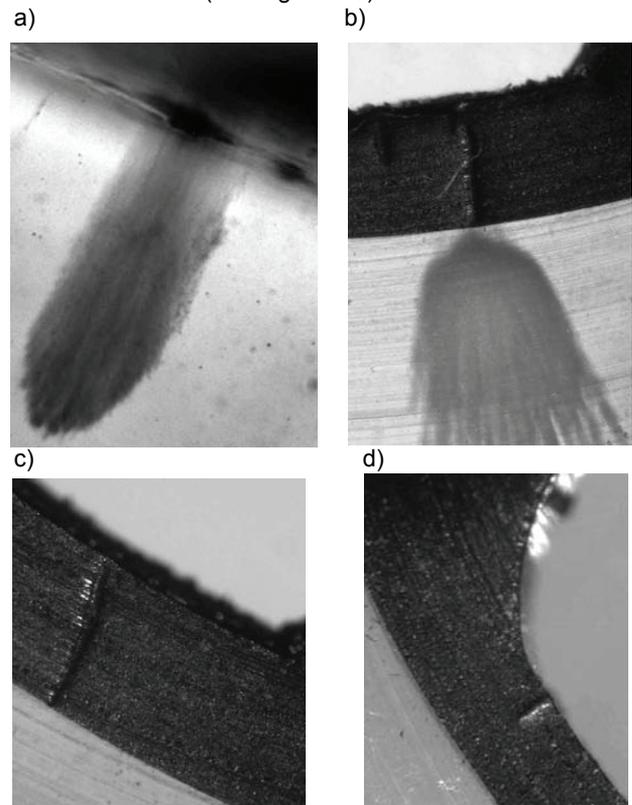
SIED structures were observed in Cable 2 and 3 as indicated in Figure 1. No such structures were observed in Cable 1 as indicated in Table 2. Cable 2 had likely water in the conductor during service, which was observed by significant corrosion products caused by water present in the interstices between the strands. However, local corrosion zones at the surface between the conductor screen and the Al strands were observed as indicated in Figure 2 b). All the observed SIED structures were located within such zones (see Figure 2 d).

Figure 1: a) A small water tree ($250 \mu\text{m}$ long) from a contamination at the interface between the XLPE insulation and the conductor screen in Cable 1. SIED structures in Cable 2 b) causing water treeing, and c) penetrating the conductor screen without causing water treeing. d) A small SIED structure detected in Cable 3.

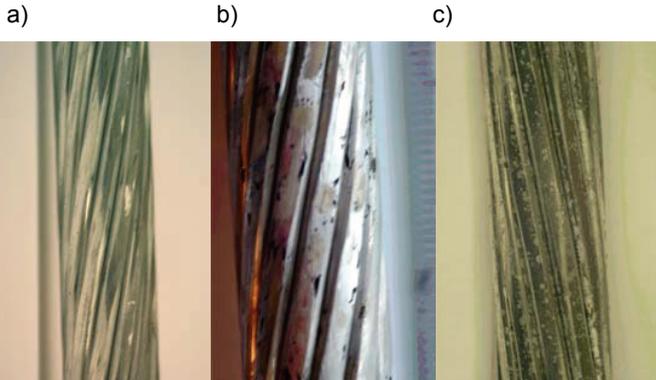
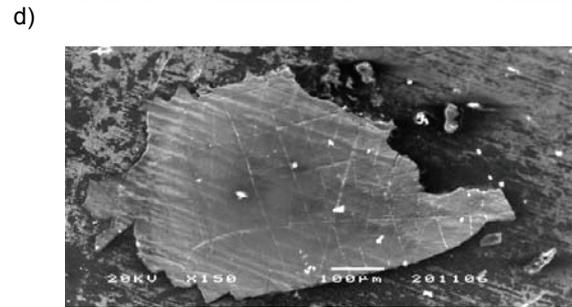
In these zones large concentrations of K, but also other inorganic elements such as Si was detected at the surface of the conductor of Cable 2. These elements were also detected within the SIED structures.

Figure 2: Photograph of the AI conductors after ageing: a) Cable 1, b) Cable 2 and c) Cable 3. d) SEM picture of a corrosion zone (light) with high concentrations of K for Cable 2.

Corrosion was also detected for Cable 3. This could be due to condensation of water in the conductor due to the pre-conditioning procedure that is used in the CENELEC test, causing liquid water to be in contact with the AI conductor (supersaturation of water) [4]. Any effect of the swelling powder on the corrosion process was not examined. However, 100% RH is not a pre-requisite for corrosion, as this also can occur at lower RH's as long as there are condensation nuclei at the AI surface causing condensation of water [7].

Inorganic elements such as K and Cl were found at the surface of the conductor strands (connected to the conductor screen). No corrosion was detected for Cable 1.

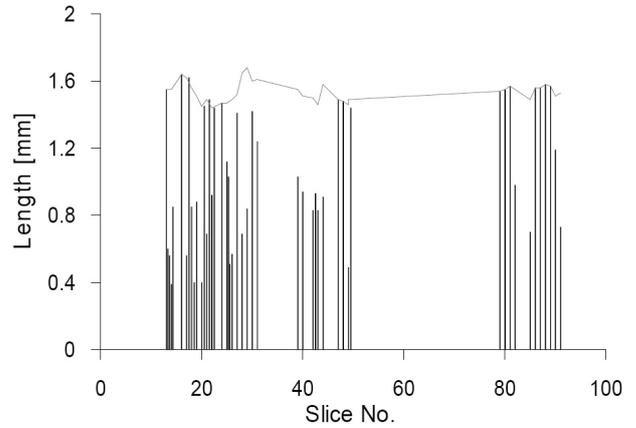
Figure 4 shows the location of SIED structures and the corresponding length along one of the AI strands in contact with the conductor screen for Cable 2. It was also found that not all the SIED structures penetrating the conductor screens initiated vented water trees as indicated in Table 2.

It was observed that the SIED structures were localized into groups. This observation was consistent with the observation of the local corrosion zones at the surface of the AI conductors, and that the SIED structures were found to initiate and grow from such zones.

Figure 4: Example of distribution of length and position of SIED structures in Cable 2 along one of the AI strands (each slice corresponds to 0.50 mm). The solid line (horizontal) indicates the corresponding thickness of the conductor screen.

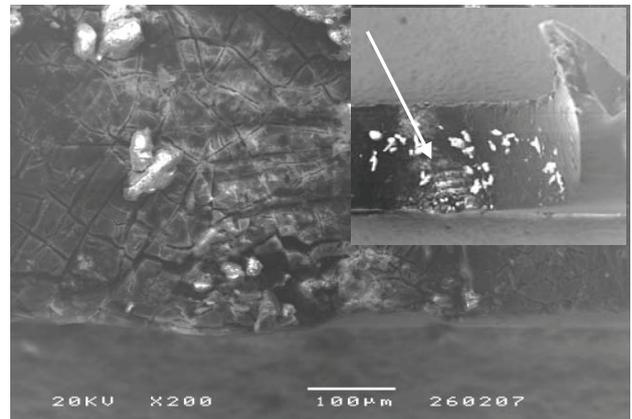
Fracture patterns were detected at the surface of the conductor screen (in contact with the AI conductor) close to the SIED structures. Figure 5 shows an example of an initiation site on the surface of the conductor screen that had been in contact with an AI strand. It was observed that the SIED structures were likely connected to such initiation sites. The surface was characterized by a cracking zone and other cracks branching to each side (with less density).

Figure 5: SEM picture of initiation site for SIED structure (see arrow indicating the enlarged area). The white particles are corrosion products from the metallic AI conductor.

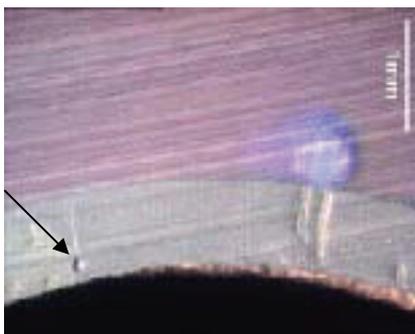
Figure 6 shows an example of water treeing and SIED structures in the XLPE model insulation system, where also ion tracks, i.e. SIED-like structures growing from defects inside the semiconductive layer, can be observed [6].

Figure 6: Example of water treeing and SIED structures in the XLPE model cables. Also ion tracks are included (see arrow) [6]

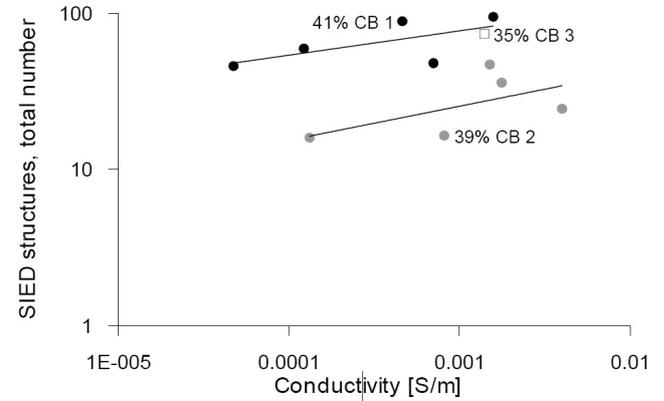
Figure 7 shows that the SIED phenomenon is enhanced with increasing conductivity of the semiconductive screen supporting the hypothesis of the galvanic cell.

Figure 7: Number of SIED structures measured in an accelerated SIED-test. The conductivity (measured at 90°C) has been varied by the carbon black content in otherwise essentially identical compounds. Three different CB types are compared.

Comparing the carbon black CB1 with CB2 in Figure 7 shows that compounds based on CB1 have developed a considerably larger number of SIED structures in the lab-scale test. The differences between these two carbon blacks are basically their reinforcing character in polyethylene matrices. CB2 involves stronger polymer-filler interactions and is believed to thus create stronger resistance to “mechanical degradation” phenomena. CB3 has a reinforcing character similar to CB1. However, it is considerably more conductive than CB1 so that it reaches the same conductivity at lower loading levels. As the response to the SIED-test is essentially the same for both compounds based on CB1 and CB3 at the same conductivity, it can be concluded that trends in Figure 6 are less likely due to variations in carbon black content, but rather due to the compounds’ conductivity and the reinforcing character of the CB, which in turn is in agreement with the proposed theory.

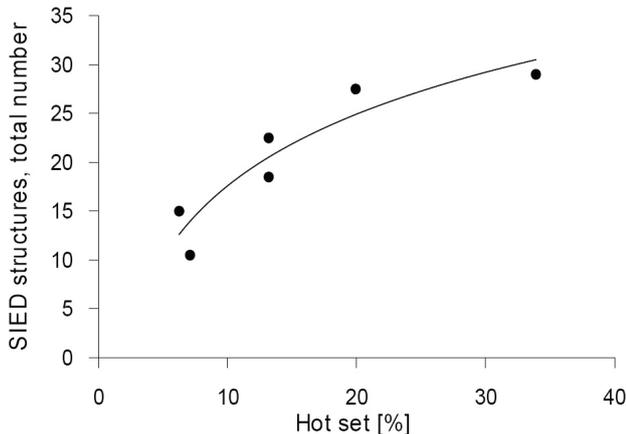
Yet another correlation between mechanical characteristics of the semiconductive layer and the response to the accelerated SIED test is shown in Figure 8. This plot suggests that a tighter cross-linking network improves SIED resistance. The hot set elongation of the semiconductive layer has been varied by changing the peroxide content (fully reacted in all samples) in otherwise identical compounds. Nevertheless, it can be assumed that not only the peroxide content, but also other factors affecting the cross-linking degree are relevant here. This

Figure 8: Number of SIED structures measured in an accelerated SIED-test. The hot set of the semiconductive layer has been varied by the peroxide content in otherwise essentially identical compounds.

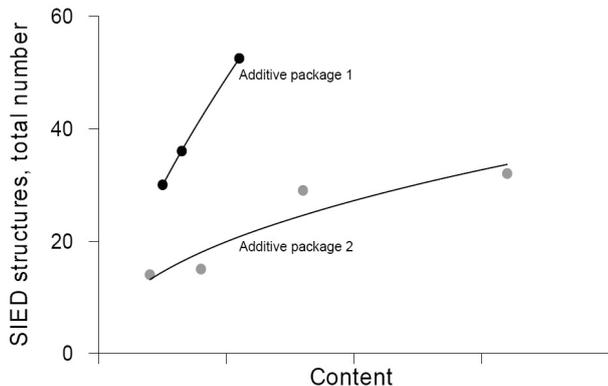
However, in formulation design the significant (perhaps strongest) impact of additivation is less understood. Figure 8 shows the additive concentration dependence of generated SIED structures.

Figure 8: Number of SIED structures measured in an accelerated SIED-test. The additive content of the semiconductive layer has been varied by the peroxide content in otherwise essentially identical compounds. Two different additive packages are compared.

Furthermore comparison of two different additive packages is showing clear differences in the formation of SIED structures. However, the effect of the additive type can be even stronger. Other model compounds resulted in well above 100 SIED structures. Although the additivation is of obvious importance it is today not quite clear in what way it affects SIED.
