End of life of underground Medium Voltage cables on Pacific Islands

Blandine HENNUY (1), Sam PIOT (2)

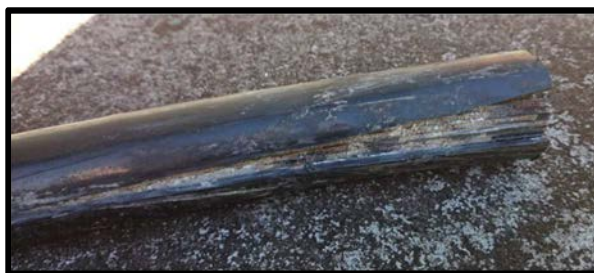
A visual examination of a piece of faulty cable revealed that the screen of the cable was completely corroded (figure 1) and at some locations only powder remained. The cable is affected for several meters whereas a longitudinal water tightness is part of the design. The cable screen is made from aluminium foil covered by a PVC outer sheath. This type of cable is used in some other countries, where they do not seem to be as severely affected by this phenomenon.

Figure 1: Damaged cable

A piece of cable will be analyzed in our laboratory within the following weeks in order to determine the exact root cause of such a degradation (salt water, damages on the outer sheath...) and it will be helpful to determine the type of replacement cable to be installed in order to avoid such failures in the future.

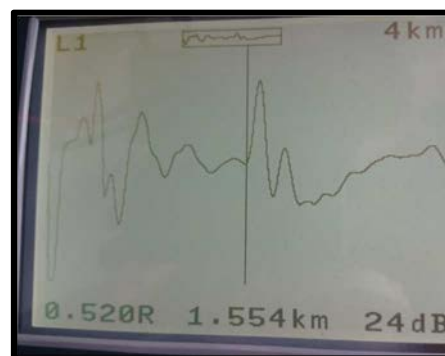
The network was built in the 1980's and the screen is grounded at the joint locations which makes the measurement of the screen even more difficult. In some cases, the only indication is the reflectometry which indicates very high losses and sometimes it's even impossible to detect the end of the cable (see figure 2).

Figure 2: Reflectometry
