Failures in underground power cables - return of experience

Bernd VAN MAANEN (1), Cornelis PLET (1), Peter VAN DER WIELEN (1), Sander MEIJER (1), Frank DE WILD (1) and Fred STEENNIS (1)

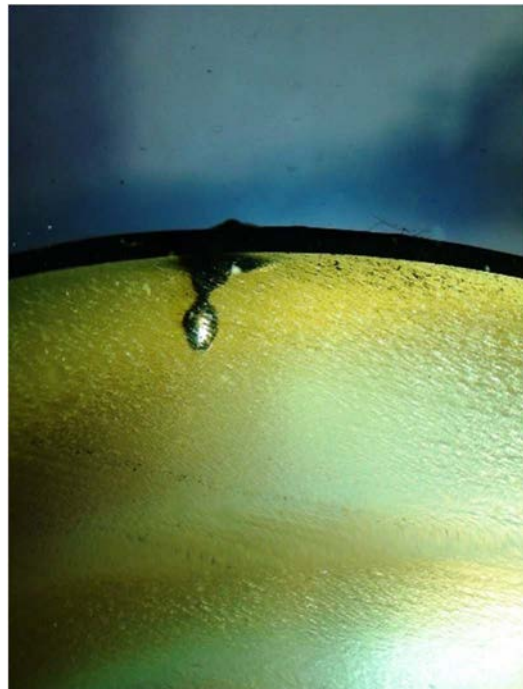
Failures as mentioned above, can be a full breakdown, but can also be a defect, like a void in the insulation material as shown in Figure 1.

Figure 1 - void in the insulation material of an extruded HV cable, causing intense PD activity during the factory acceptance test.
