Accelerated aluminum corrosion upon water ingress in damaged Low Voltage underground power cables.

Bart **KRUIZINGA** (1), Peter **WOUTERS** (1), Fred **STEENNIS** (2,1)

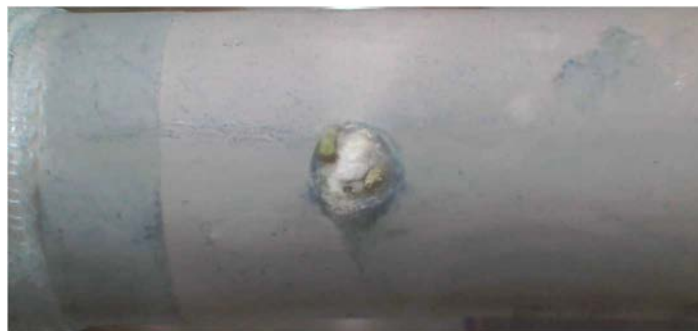
Figure 1: Example of aluminum corrosion in a 6 mm hole.

During the first days, the speed of the process already shows to be significant. A 6 mm in diameter hole, drilled into the conductor, fills up with aluminum oxide within several days. A continuous release of hydrogen gas bubbles is observed. During the testing period, the density of oxide seems to increase and flakes of oxide are released into the water. At a later stage, small holes releasing hydrogen bubbles show that the oxidation continues. Current levels are generally in the order of several milli-amperes, varying over time. Further characterization of the current is currently under investigation.
