## MV CABLE TERMINATION FAILURE PREVENTION, ONLINE DIAGNOSTIC METHOD APPLICATION.

Thierry **ESPILIT** (1), Fabrice **ZORZI** (1), Roger **TAMBRUN** (2),

1 - EDF R&D, Moret sur Loing, France, thierry.espilit@edf.fr, fabrice.zorzi@edf.fr

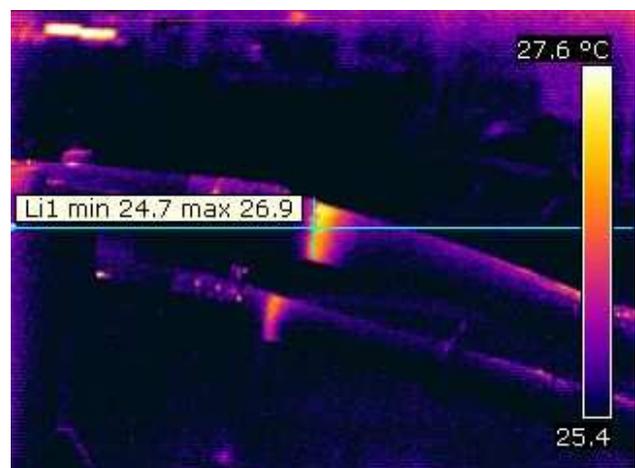
Moreover, temperature increase of the stress control material has been observed under nominal voltage application.

**Figure 1 : Stress control heating under nominal voltage**
