## Watertight Cable Designs in Hydropower Generation Plants

This paper considers the problems with induced currents in copper screens and aluminium laminate, consequences and improvements for a 24 kV watertight XLPE cable system. Repeated faults on a heavily loaded new cable system installed for the generators of a Norwegian hydropower generation station resulted in serious doubts about the performance and life expectancy of the installed system. At times during the project, a full replacement with new cables was seriously discussed. The costs involved would, however, be substantial. Hence a team consisting of parties involved was set up with the aim to try to come up with a reliable solution to avoid replacement of the cable system.

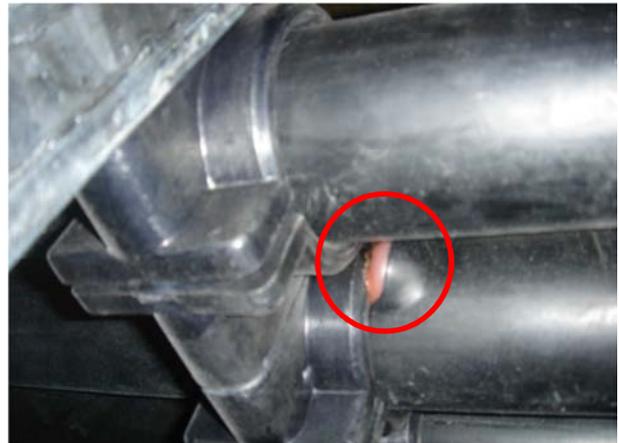
As more attention was given to the new cable system, more emerging faults were detected. Mainly heating and burns beneath the terminations at the screen grounding, and bubbling/melting of outer sheath under cable cleats was detected. All findings were within 0-25 m from the cable terminations. Damaged cables were cut out and replaced by spare cables and joints as new emerging faults were detected.

Fig. 1: Example of bubbling/melting of outer sheath under cable cleat caused by heat from laminate and screen wires [1].

As time went on new emerging faults were detected at the replacement joints. As by the terminations, the area where the laminate was cut by the joint tended to heat rapidly. At this point heavy loading of the cable system and high ambient temperatures was suspected to be the cause of failure. With a full load conductor current of approximately 900 A, a total of 195 A current would be induced, divided between the laminate (65 A) and copper screen (130 A).
