## Reliability on existing HVDC links feedback

Patrik LINDBLAD; ENTSO-E Task Force HVDC Reliability, (Finland),  
[patrik.lindblad@fingrid.fi](mailto:patrik.lindblad@fingrid.fi)

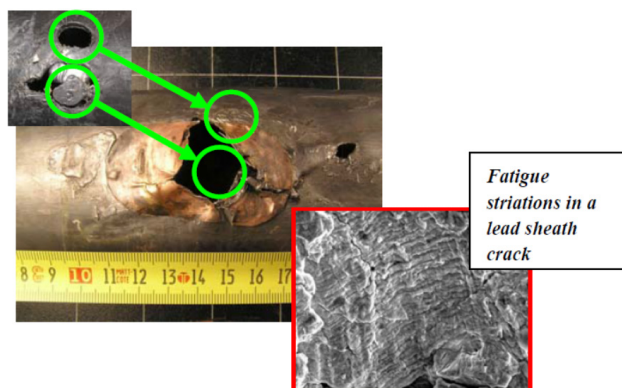
Fig. 1: Internal failure of Fenno-Skan 1 MI-cable

Comprehensive QA (Quality Assurance) and type testing is essential in verifying the cable design and manufacturing quality. One example of an internal quality error is from the Fenno-Skan 1 cable, which suffered from two similar trips in 2005-2006 due to a hole in the lead sheath at earthing connection points, which were found to be not fully according to the design instructions. Damage in the lead sheath may have caused fatigue cracking in it during expansion and contraction cycles over the years of operation, through which water may have finally been able to penetrate to the insulation. Additionally the very thin earthing wire could have been damaged during the cable manufacturing. In the end, the root cause remained uncertain. The cable repair times in these two breakdowns were 87 days and 71 days, respectively.

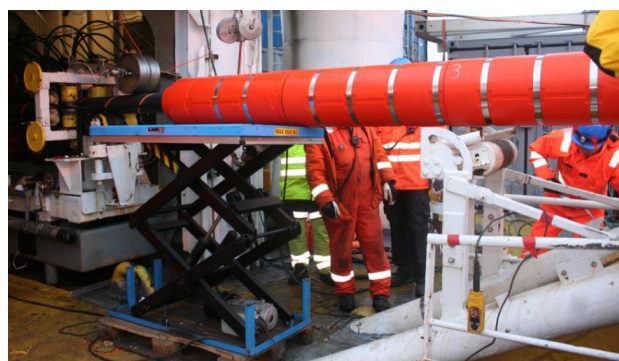
Fig. 3: Crossing PPL-duct of EstLink2

Cable crossings may be another challenge. They must be designed with care. EstLink 2 output power had to be limited 25-100 MW from nominal 650 MW during 5 months 2015 due to high cable temperature alarm located at a cable crossing. The main crossing design is with PPL-duct (separation and protection). There are 18 crossings with 21 different cables and pipes, with a total length 0.5 km. For securing the nominal power transfer capability of the cable, the upper half of the PPL duct was removed in all cable crossings in water depth lower than 30 m.

- The fibre optic temperature measurement system may need calibration over a longer distance. There was an error: the actual temperature was lower than the temperature measured with the optical fibre.
- There is a need for proper crossing design selection taking into account the thermal properties of soil and protection method, including also the effect of the crossing sinking in the seabed.

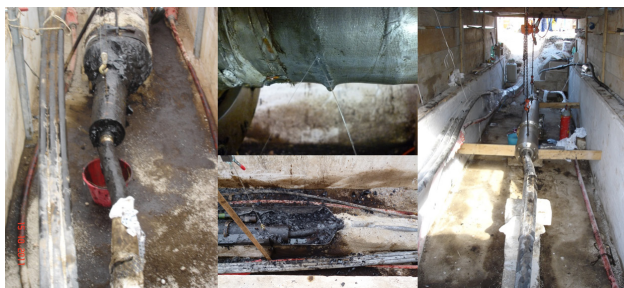
**Fig. 4: Damage in joint failure of GRITA**

GRITA (GRE-ITA) HVDC-interconnector with both 43 km land and 163 km submarine cable sections was commissioned in 2001. Failures started to occur on the joints of the 400 kV SCFF land cable after 8 years of operation. When the fault rate increased in the age of 12, it was decided to replace all joints.

Cracking of the lead sheath occurred a few inches from the joint due to misalignment of the cable-joint axis. Root cause for this was excessive overheating and melting of bituminous compound inside the outer protection of the joint. As a consequence, there was leakage of oil.

The repair solution adopted for the 50 joints was a completely new design, laid in rigid configuration and with improved thermal capacity and thermal monitoring. Repair work duration was 19 workdays per joint. It consisted of:

- removal of outer PE protection of joint and bituminous compound,
- lapping of inner part of joint with self-amalgamating tape and application of heat shrinkable tube against water penetration and for mechanical protection,
- cable-joint axis alignment (if not in correct position),
- adding thermal gauges for thermal monitoring,
- filling joint bay with high thermal conductivity backfill.

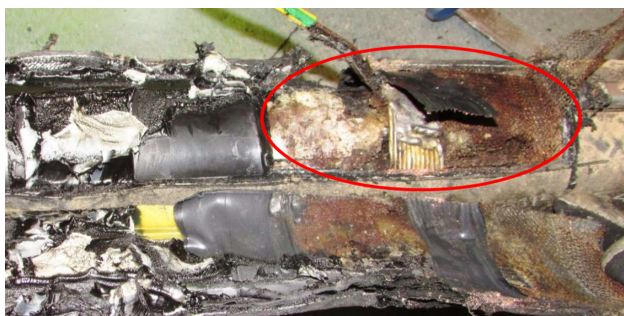
**Fig. 6: Moisture damage in EstLink 2 joint failure**

The root cause of the faults was the way the earthing wire was installed in the joint. The earthing wire installation enabled water to penetrate into the joint, compromising the lifetime of all the joints with the same design. In addition the earthing wire installation procedure did not include detailed information of the required water ingress protection measures.

- Based on new calculations, not all of the joints needed to be earthed. The original calculations were on the conservative side.
- It could be advantageous to repeat type testing for any possible design modifications, even if they are small.
- The faults might have been noticed by more effective site supervision: neither the installers nor the supervisors noticed that the installation was not going to be fully waterproof.

EstLink 2 (EST-FIN) suffered in 2014, after less than one year of operation, from two trips due to joint failures on the MR (Metallic Return) XLPE type UG (underground) cable on Estonian side. Outage duration was 12 days and 8 days, respectively. Finally, all 11 joints on the length of 12 km were replaced with new ones.

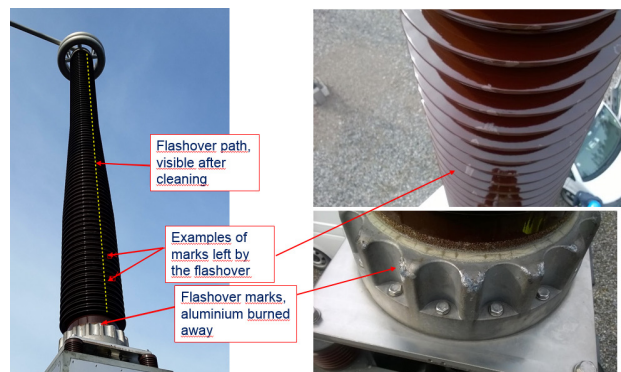
Fenno-Skan 2 (SWE-FIN) 800 MW LCC link suffered from several (8 pcs) 500 kV DC circuit earth faults occasionally during years 2012-16, usually at humid weather and near to 0 °C temperatures. The DC circuit consists of both OHL and submarine cable sections. Mostly, automatic re-start of converter was successful. Open line tests did not reveal the fault location. Establishing the root cause was difficult:

- Firstly, flashover in overhead line section was suspected. Nothing was found during patrols.
- Secondly, flashover in DC equipment was suspected. Nothing was found in inspections conducted from ground level. Based on TFR curve readings, it wasn't even possible to determine with certainty whether the fault was on the Swedish OHL, submarine cable or Finnish OHL side.
- Thirdly, thorough warranty inspection of cable end termination was done 2015, and marks of a flashover was found on the porcelain insulation surface. It was to be seen clearly only from near distance and in an outage.

Root cause of the faults was that creepage distance of cable end termination porcelain insulator was designed too near to its limits, for the environmental conditions it was put into. Actual conditions like humidity, icing, frost and icy fog & rain were not handled by the specification nor the design of the termination and this caused

flashovers at the termination in the named severe conditions. Instead of replacing the cable end termination, the electrical withstand level of the termination in these severe conditions was improved by coating the termination. The coating may increase the maintenance efforts and costs to the respective TSOs. As a lesson, the creepage distance and electrical withstand should be specified higher due to the environmental stress in future contracts. Conditions requiring this may also be due to pollution or salt from sea.
