## THE 33 KM LONG 87/150(170)KV KOKSIJDE-SLIJKENS LINK

*A 87/150 kV underground link of 33 km has been built in the north of Belgium. This paper describes the different steps between the start of the project, to the final acceptance tests, with special consideration of the AC voltage test after installation on such a long link.*

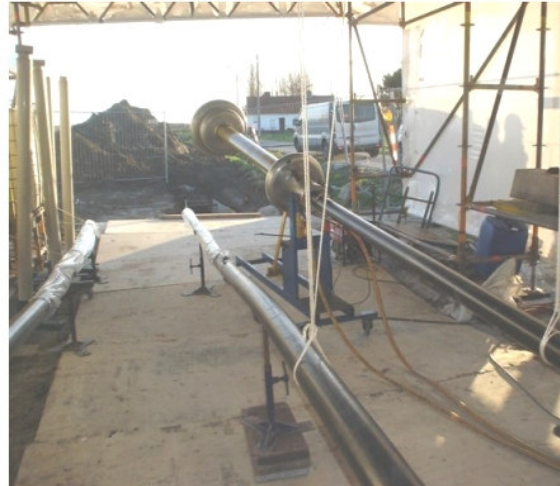
**Figure 2: temporary termination used for testing the link in three sub-links (injection of  $2U_0$ )**

In order to perform the tests on the sub-links, laboratory water terminations and stop joints (blind terminations) have been used. The water terminations allows to inject the  $2U_0$  voltage on the sub-link of which is on the middle, and also on the sub-link on the Slijkens side where the terminations are GIS type. The stop joints allow not using terminations where it is not necessary (see Figure 1)

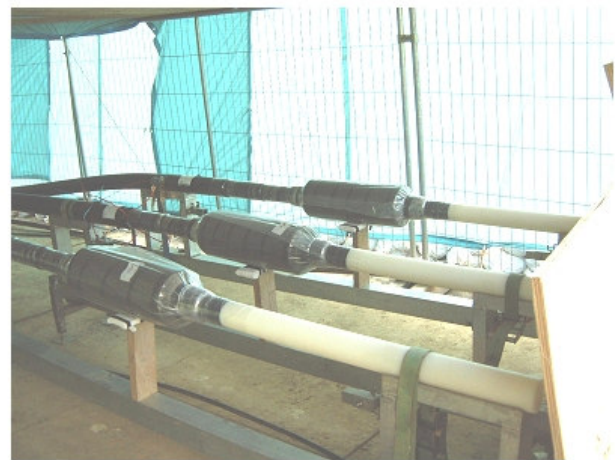
**Figure 3: stop joints (blind terminations) used for testing the link in three sub-links**

After these  $2U_0$  tests, the stop joints and the laboratory terminations were removed, and replaced by the 6 definitive joints. In order to test the 6 last joints, a 24h soak test ( $U_0$  without load), which is an existing possibility of IEC 60840, was successfully performed on the 33 km link.
