## RE-EVALUATION OF 150 KV CABLE CAPACITY

Dirk VAN HOUWELINGEN, ENECO-Netbeheer, (Netherlands), d.vanhouwelingen@netbeheer.eneco.nl  
 Jos VAN ROSSUM, PRYSMIAN Cables & Systems B.V, (Netherlands), jos.rossum@prysmian.com

In asset management an update of asset data is necessary as circumstances change. In 2004 ENECO-Netbeheer and Prysmian cables and Systems BV re-evaluated the status and transport capacity of old 150 kV cables. This paper describes the results.

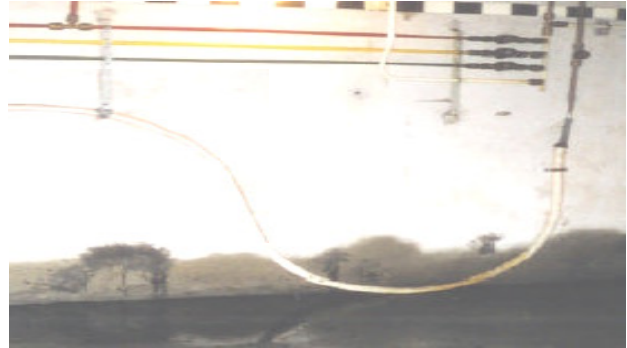
Figure 4: oil spill at Geervliet

- Waalhaven-Oudeland: leakage of oilcontainer at joint 6.
- Waalhaven-Botlek: oil leakage in the hydraulic system in Geervliet (see figure 4); minor defects in the hydraulic system in Waalhaven
- Waalhaven-Vondelingenweg: high tan delta in oil, representing some ageing of paper isolation
- Botlek-Oudeland: high tan delta in oil, representing some ageing of paper isolation

In general the cables are in good condition. Provided that all defects are repaired, continued operation is possible. A new assessment is advised in 5 years.

As a result of the condition assessment ENECO has carried out the necessary repairs. This was done in the months following the assessment.

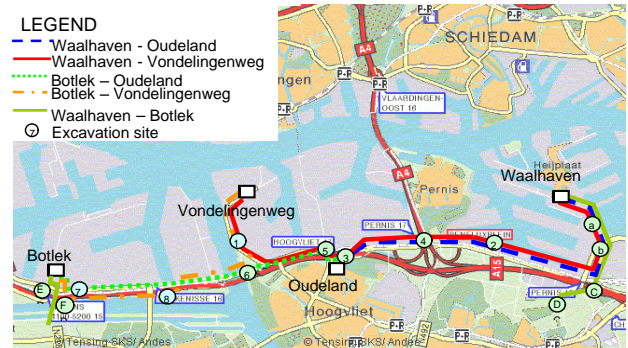
A detailed map of the area with the cables is shown in figure 7.

**Figure 7: Detailed map of cable trajectories**

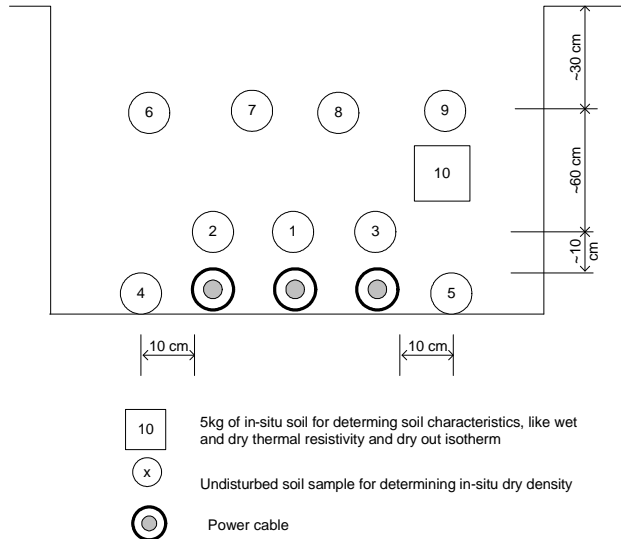
The actual soil thermal resistivities are determined by taking soil sample in trail holes. Figure 9 shows the position of the soil samples taken at each trail trench.

**Figure 9: Soil sampling location per trail trench**

As indicated in figure 9, the following soil characteristics are determined:

- o the in-situ soil thermal resistivity during sampling,
- o the nominal in-situ soil thermal resistivity (average value throughout the year)
- o the in-situ soil thermal resistivity in dried-out conditions
- o the dry-out isotherm of the in-situ soil. Please note this is the isotherm between dry soil and wet soil.

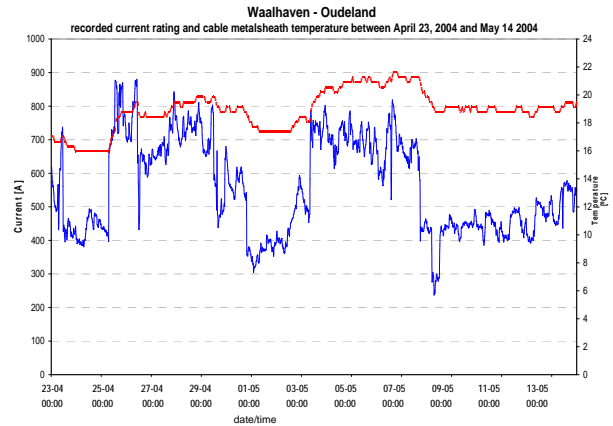
At the trail holes, thermocouples were installed on the cable outer sheath. With the aid of a stand-alone data recorder the temperature and the current load through one cable phase were recorded every 5 minutes during several weeks (23-4-2004 to 15-5-2004). A typical sample of the measurements is shown in figure 10.

**Figure 10: Measured current (thin blue line) and cable outer sheath temperature (thick red line)**

As explained in the verification model, the average current rating is determined and the corresponding outer sheath temperature is calculated. Then, this outer sheath temperature is compared with the measured average outer sheath temperature. In those cases where differences are significant, the input parameters are reconsidered. One should consider that circuits under low load result in small sheath temperature rises and the actual undisturbed ground temperature is unknown. Consequently a large uncertainty is expected in the sheath temperature calculation. Or, stated otherwise, a range of soil parameters fits the measured sheath temperature and current curves.
