## UPGRADING QUALITY OF 275KV Y-BRANCH PRE-FABRICATED TRANSITION JOINT

In order to utilize existing underground power cable line effectively, the demand of Y-branch transition joint box (hereafter called as YJB), which can branch the existing line by jointing new line, is increasing for EHV cable line in recent years.

This paper introduces (1) upgrading of manufacturing inspection for 275kV YJB, (2) performance evaluation of installed YJB at the time of rapid temperature change in the manhole, and (3) workability of installation and recovery for such large and heavy YJB in the narrow manhole.

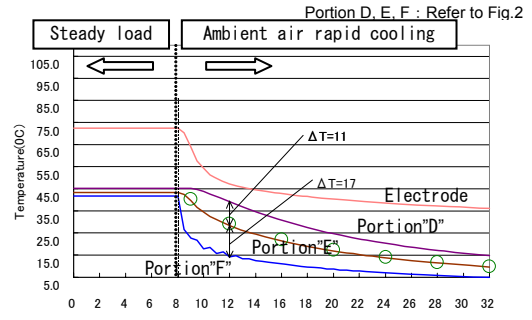
- (3) In the case where operation is made in a manhole, YJB suffers sudden temperature change as shown in Fig 3-1 due to sudden drop of ambient air temperature when the manhole is opened during winter season. Through thermal stress analysis, it was then found that large stress yielded on the surface of epoxy as shown in Fig3-2.

Fig.3-1. Thermal distribution of epoxy unit (40→0 °C)

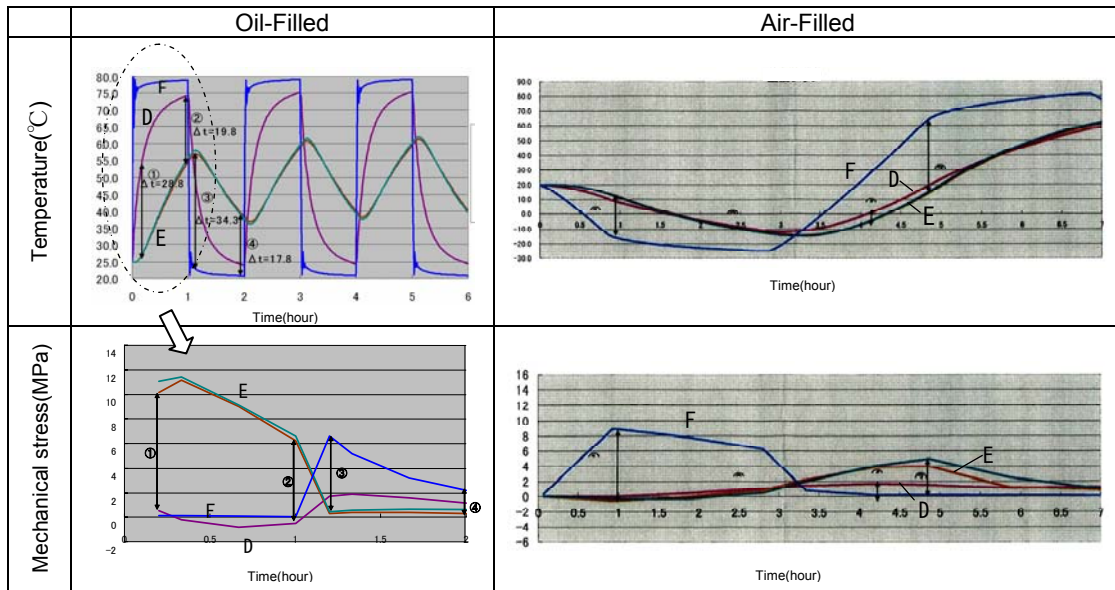
- Using thermo-mechanical analysis, it is confirmed that they are equivalent, the stress generated on the surface of epoxy under both oil-filled and air-filled circumstances as shown in Fig5.

Fig.5. Thermal and stress distribution of epoxy unit during heat-shock test

Table 1 shows the stress generated at every heat-shock test. Air-filled method showed crucial result on the surface where external damage can be detected. On the other hand, oil-filled method showed crucial result inside epoxy. But the stresses revealed are sufficiently larger than that generated during operation, and the high-voltage electrode side can be screened with PD test. It was confirmed air-filled method was substantially effective as shipping test.

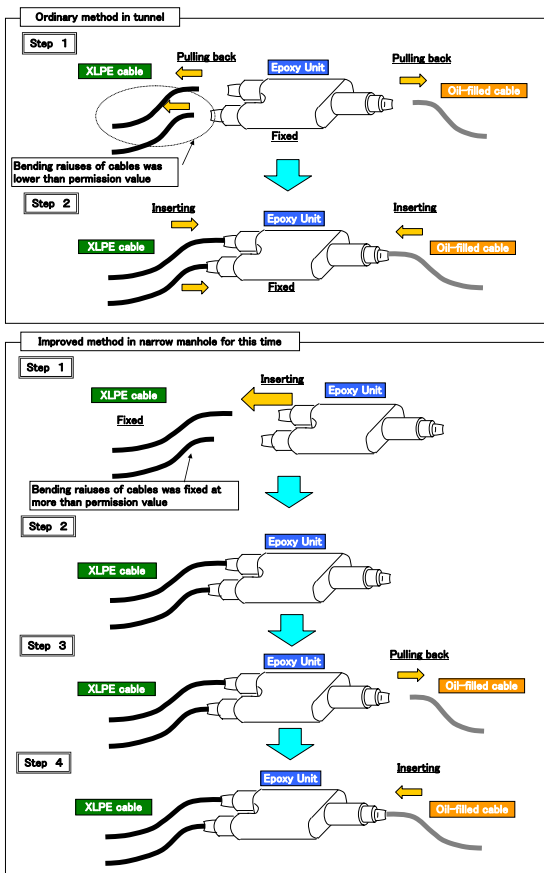
Fig. 7 shows construction flow of 275 kV YJB in a narrow manhole. In the case where sufficient construction space is maintained, such as in tunnel, a construction method in which epoxy unit is fixed as shown in Fig. 8, each cable is once pulled back, and is then inserted into the unit, may be adopted. But in the case of this time, construction space of the existing narrow manhole was limited. This

Fig.8. Method of constructing YJB

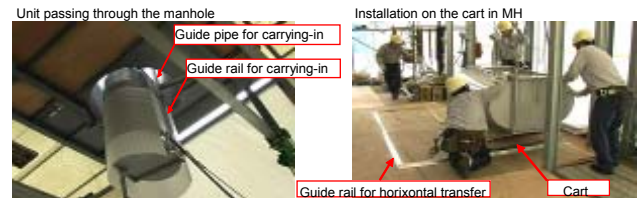
- Prepare and apply a carrying case for epoxy unit.
- To prevent external damage during passing through the carry-in hole, mount a guide rail on the side of carrying case for the unit, and carry it in with it fitted to the guide pipe installed on the carry-in hole.
- To prevent external damage from causing during carrying in through the manhole, along the guide rail installed on the floor the manhole.

A simulated manhole whose dimensions are the same as the narrow manhole on the site was constructed and conducting carrying in test of epoxy unit. It was confirmed to be carried out successfully. Fig. 9 shows the appearance of the test.

Fig.9. Appearance of carrying test of the epoxy unit into the simulated narrow manhole

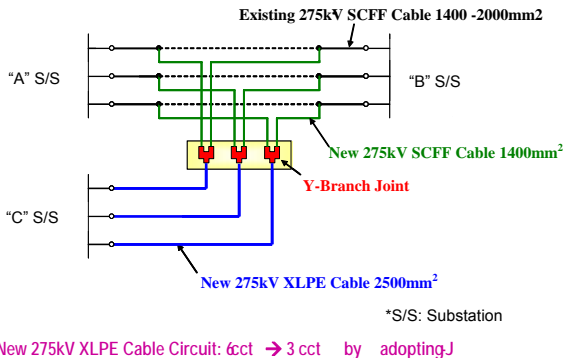
JPS is currently undertaking construction of 275kV YJB for TEPCO. Figure 14 shows the scheme of the line.

In this construction work, nine sets of YJB for three circuits are installed. XLPE 2500mm<sup>2</sup> cable is installed to the single-mouth side and two SCFF cables are installed to the two-mouth side. Two circuits are in operation and one circuit will be in commission in June 2007. Fig. 15 illustrates the installed YJB in tunnel for TEPCO.

Fig. 14. Outline of line using 275kV YJB for TEPCO

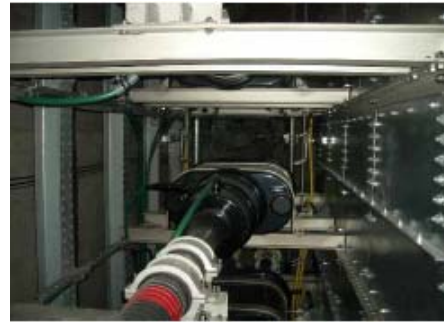
Fig.15. Installed YJB in the tunnel of TEPCO
