## FIRE PREVENTION METHOD FOR 275KV OIL-FILLED CABLE IN TEPCO

Atsushi Toya, Tokyo Electric Power Company, (Japan), toya.atsushi@tepcoco.jp  
Shinsuke Nasukawa, Tokyo Electric Power Company, (Japan), nasukawa.shinsuke@tepcoco.jp

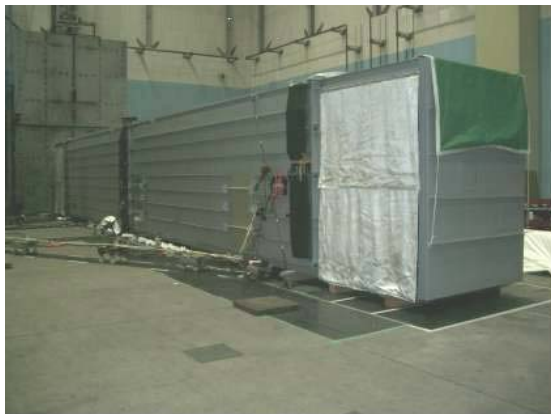
- Installing real cables and joints
- Making the fault point by a metal nail
- The conductor and the sheath are short circuited, using short circuit current generator
- Fault current and its duration are decided based on the power system condition
- Tested in the similar environment as the actual installation using a mimic tunnel (fig.3 and fig.4)

**Figure 3: External view of mimic tunnel**

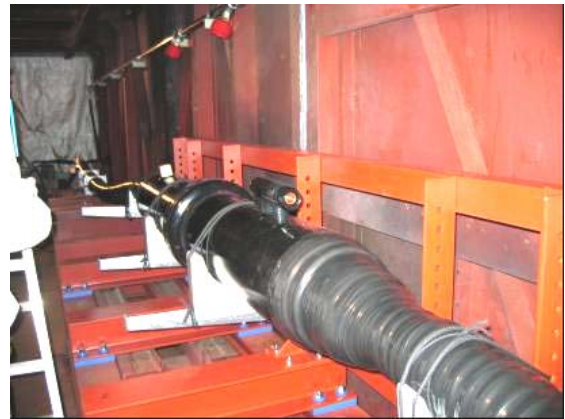
**Figure 4: Example of short-circuit test**

- Short-circuit arc decomposes oil and insulating paper
- The inner pressure of cable/joint increases.
- Arc itself and inner pressure rise destroy cable sheath or joint case.
- Arc heating ignite fire of leaked oil and paper
- Supply of oxygen spreads fire

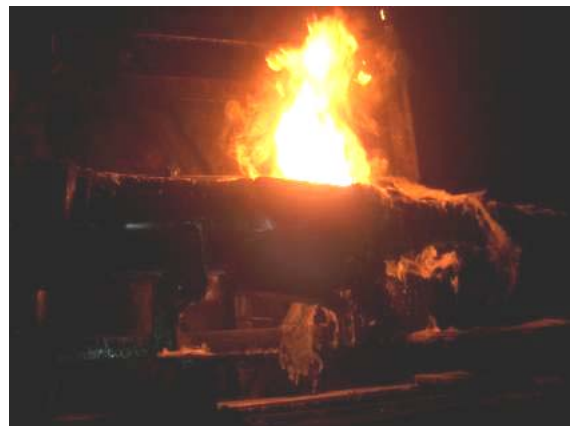
**Figure 5: Ignition by ground-fault**

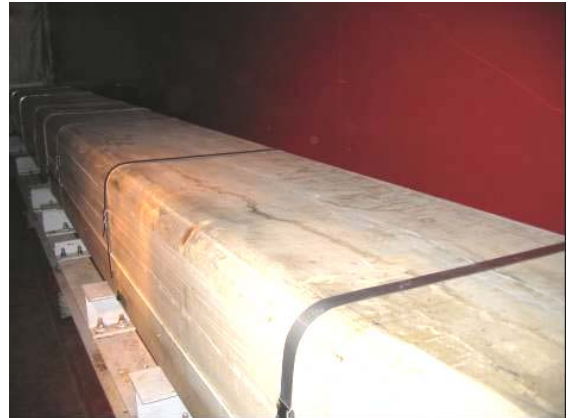
In tunnel, cables are laid in FRP trough (see fig.6). It blocks oxygen supply and prevent catching fire. It is important that the trough should not be broken nor the trough cover should not be displaced by explosive pressure. It is necessary to design proper material, cross-sectional area, and thickness of trough, and to choose proper material, width, and interval of the bands binding trough cover. Specifications are decided by calculations and short-circuit tests.

Figure 6: Example of fire prevention method for cable in tunnel by FRP trough

If the specifications of trough and its band are fixed, binding interval is controlled so that the trough cover should not be displaced in assumed pressure. Pressure generated by the fault depends on fault current and cross-sectional area of the trough. And necessary binding interval is decided accordingly.

Fault current becomes larger as the power system expands, and the generated pressure inside the trough becomes larger, too. It is not reasonable if the binding interval is too short. Trough itself may not withstand the fault shock. In this case, the spec of trough may be modified, or the trough may have a pressure discharge function.

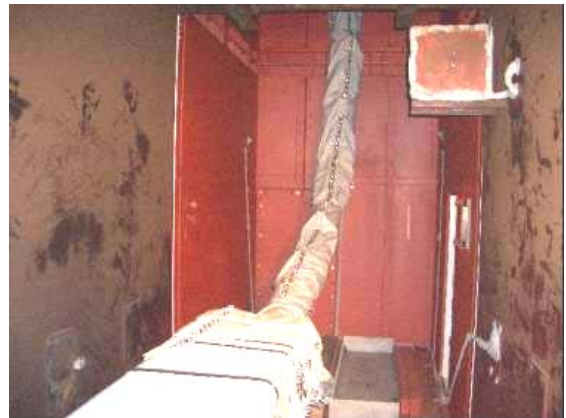
In cable offset and shaft, where it is difficult to apply FRP trough, plastic hose and aramid sheets are applied as shown in fig.7. Plastic hose works as anti-arc protection and keeping shape, aramid sheets work as anti-pressure protection.

Figure 7: Example of fire prevention method for cable in shaft
