DIAGNOSTIC TESTING OF MV ACCESSORIES BY TIME DOMAIN SPECTROSCOPY (TDS)

Carl Potvin, Institut de recherche d'Hydro-Québec (IREQ), (Canada), Potvin.Carl@ireq.ca
 Daniel Jean, Institut de recherche d'Hydro-Québec (IREQ), (Canada), Jean.Daniel@ireq.ca
 Daniel Lalancette, Institut de recherche d'Hydro-Québec (IREQ), (Canada), Lalancette.Daniel@ireq.ca
 Jean-Luc Parpal, Institut de recherche d'Hydro-Québec (IREQ), (Canada), Parpal@ireq.ca
 Jean-François Drapeau, Institut de recherche d'Hydro-Québec (IREQ), (Canada), Drapeau@ireq.ca
 Simon Bernier, École de Technologie Supérieure (ETS), (Canada), Stintense@gmail.com
 Richard L'Écuyer, Institut de recherche d'Hydro-Québec (IREQ), (Canada), Lecuyer.Richard@ireq.ca

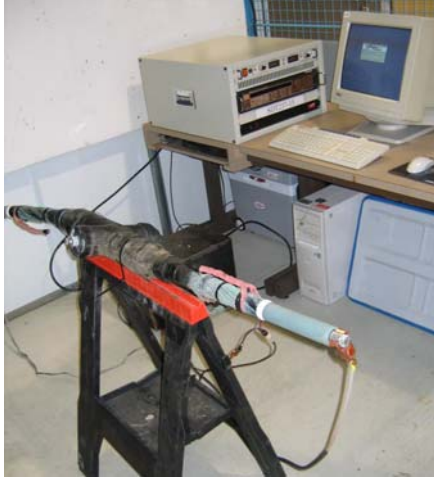
Figure 3: TDS device (ungrounded) developed at IREQ and used for joint characterization

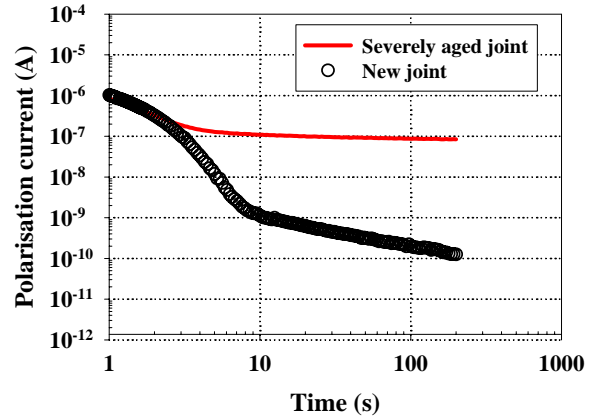
Results of the polarization and depolarization currents measured with the TDS on a severely aged and a new joint are presented in Figures 4 and 5 respectively.

Figure 4: Time dependence of the polarization current for a new and a severely aged joint as measured with the TDS device

These two cases illustrate the different universal relaxation processes described by Joncher [7], except for the first ten seconds where the current is driven by the capacitive (RC) contribution of the circuit. In polarization mode (Figure 4), a charge carrier process dominates the current component of the severely aged joint (hot spot). In such a case, the measured quasi-conduction current results from a local degradation in the joint. For the new joint, the polarization current results from the combination of dipolar and interfacial polarization. The dipolar process will generally dominate for short times while interfacial polarization dominates for long times. These two processes result from the presence respectively of permanent dipoles and different dielectric materials contained in the insulating material. In the depolarization mode (Figure 5), the current result only from the combination of dipolar and interfacial depolarization for the two joints.

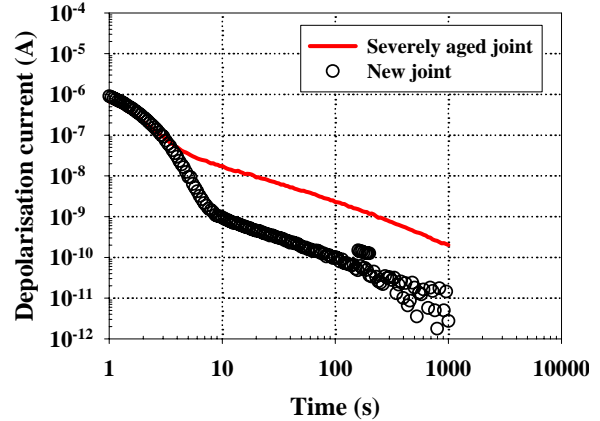
Figure 5: Time dependence of the depolarization current for a new and a severely aged joint as measured with the TDS device

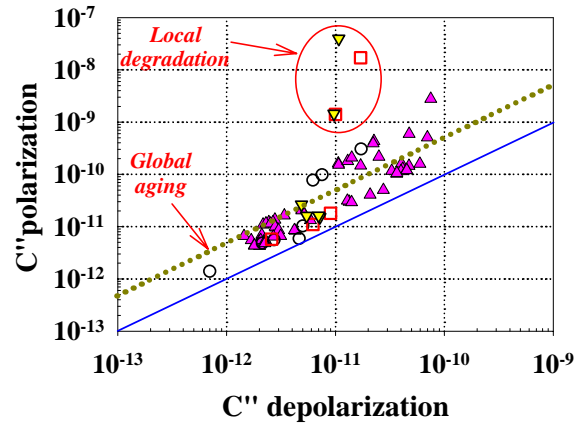
In order to compare the different state of aging between joints recuperated from service, polarization and depolarization losses at 10⁻³ Hz were plotted on a graph. The results obtained on the 78 joints, listed in Table 2, are presented in Figure 6 in terms of the imaginary capacitive component C'' which can be expressed as:

The C'' plots allow a better comparison between joints instead of tg δ since the capacitance is strongly dependent on the joint design geometry. The preliminary analysis of the dielectric losses (C'') in polarization and depolarization of all joints recuperated from service suggest at least two aging mechanisms: (i) global slow degradation of joint insulation by water treeing [10, 11] and (ii) local degradation for specific joint designs. In Figure 6, the dotted line represents the trend of the global (water-tree) aging while the joints that showed hot spots (some specific design) are shown in the ellipse. A dotted line showing the global-aging trend was arbitrarily drawn for the joint insulation parallel to the theoretical limit represented by the solid line. The theoretical limit relates to the case where the depolarization and polarization currents are equal (considering that, in any

Figure 6: Dielectric losses at 10⁻³ Hz and 5 kV of all the joints measured with the TDS device

The C'' analysis also showed that insulation degradation is not correlated to the time in service and that there could be a substantial difference in dielectric losses between different joints installed on the same line, several aged joints presenting dielectric losses similar to new ones.

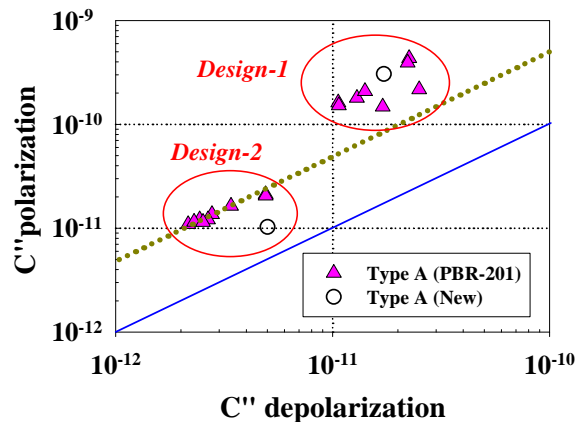
The joints recuperated from service were of six different designs. Although their losses in general seem to follow the same global-aging trend, some joint designs are more susceptible to local degradation which can lead to hot spots. The losses specific to each joint design are presented in Figures 7 to 12. Apart from joint types B and F (taped), the dielectric losses of new joints are always included as reference. Joints referred to as type A are commonly used for replacement after a joint failure or hot-spot diagnostic. The TDS dielectric losses of type A joints present two clusters of points that correspond to two different joint designs, Figure 7.

Figure 7: Dielectric losses at 10⁻³ Hz and 5 kV of 17 type A joints recuperated from the PBR-201 line

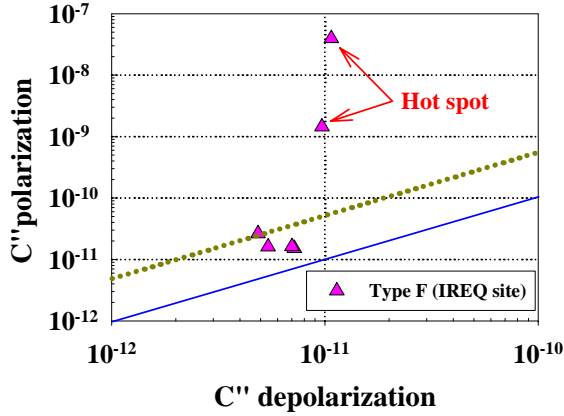
The type F joints were taped and had been in service at the IREQ site for 34 years: they were replaced after hot spots on some joints had been diagnosed. The resulting losses for six of these joints are presented in Figure 12, but no reference (new joint) is provided since the technology had been replaced many years previously and required skilled personnel. It is interesting to note that, apart from the two joints with hot spots, the others show very little aging.

Figure 12: Dielectric losses at 10^{-3} Hz and 5 kV of six type F joints recuperated from the IREQ site

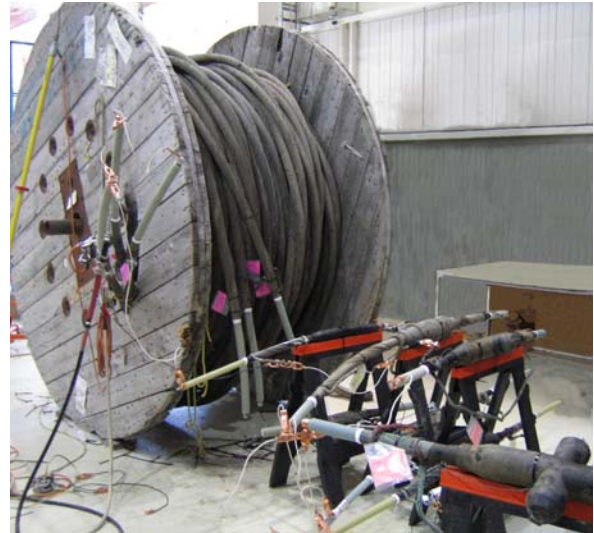
In order to confirm the major contribution to the dielectric losses of some joints with advanced insulation degradation, a line simulation was performed at IREQ. Standard TDS measurements were performed on ~200-m-long cable section (3 phases) on a reel (recuperated from the network) and eight joints: two new ones and six presenting various degrees of degradation, Figure 13.

Figure 13: Set-up of cables and joints used for the line simulation measurements

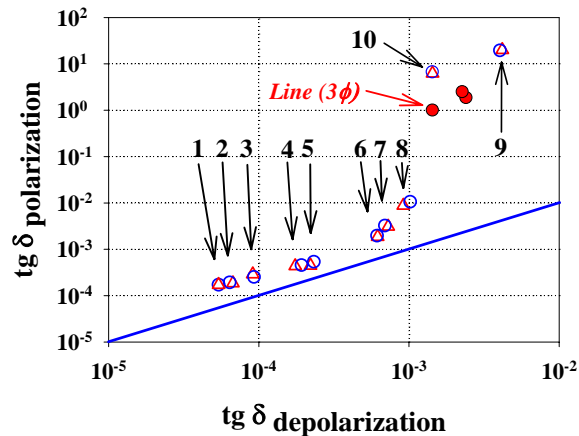
The evolution of the measured and calculated dielectric losses (at 15 kV and 10^{-3} Hz) for the different combinations is presented in Figure 14 together with those measured on the three phases of a Hydro-Québec line. The TDS dielectric losses of the three phases (3 ϕ) of this line, presented as a reference in Figure 14, are considered to be representative of a line with degraded joints [4].

It can also be seen in Figure 14 that the cable alone (#1) presents the lowest losses and that the addition of new and moderately degraded joints results in an increase in the polarization and depolarization losses (#2 to #9). The point corresponding to the number #9 combination is the one with the addition of a joint that was diagnosed with a hot spot as the type C one shown in Figure 9. It is interesting to note that the last combination (#10) in Table 3 corresponds to a

Figure 14: Evolution of the measured and calculated losses of a cable with different accessories (Δ: measured, ○: calculated)

~600-m line (the three phases connected together) and that the losses are simply divided by a factor of 3 due to the capacitance increase. However, even in that case the total current of the all combination results only from the last joint (J8) added. The dielectric losses of this simulated line with a "weak link" can then be expressed as:
