50Hz Partial Discharge Diagnostics – Experiences of N-Ergie AG Minimising cable failures by Reliability-Centered Maintenance of Networks

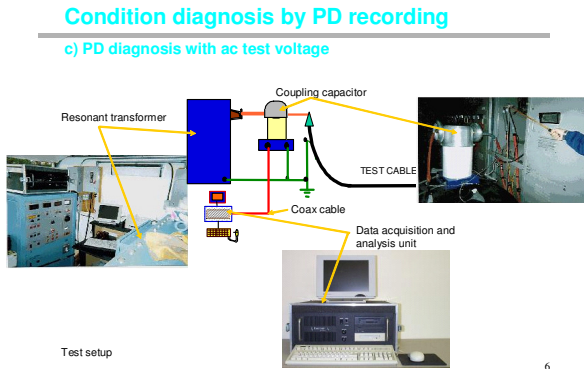
Figure 2

The test methodology is based on the principle of reflectometry. The system allows to detect and locate partial discharge signals. The test set-up is shown in figure 2.

The test is executed in 4 steps:

1. Measurement of cable length and splice locations

A pulse generator injects a pulse into the cable from one cable end. Analysis of the reflectogram allows to determine cable length and splice locations.

2. Calibration and Measurement of sensitivity

The sensitivity measurement determines the influence of the cable attenuation.

3. Partial Discharge test with 50Hz

A resonance transformer supplies the 50Hz voltage. The test is done in different voltage steps.

4. Signal analysis and test report

The processing unit captures, saves and analyses the partial discharge signals. Adaptive digital filtering allows detection of even those signals with very low signal-to-noise ratio.

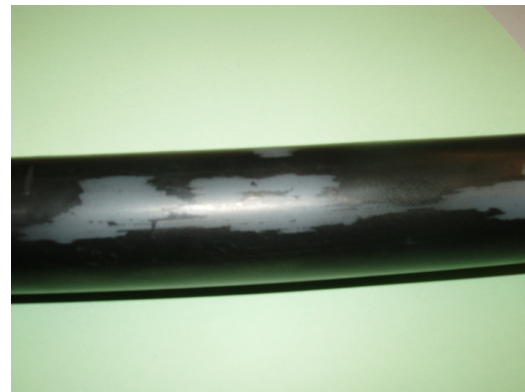
Figure 4: Delamination

During test of an extruded cable, discharges were located at 59 meters. Based on the Imcorp interpretation criteria, the problem was assessed as an Electrical Tree or a delamination. The utility investigated and informed NexaTec of the result: a clear delamination case (see figures 3 and 4).

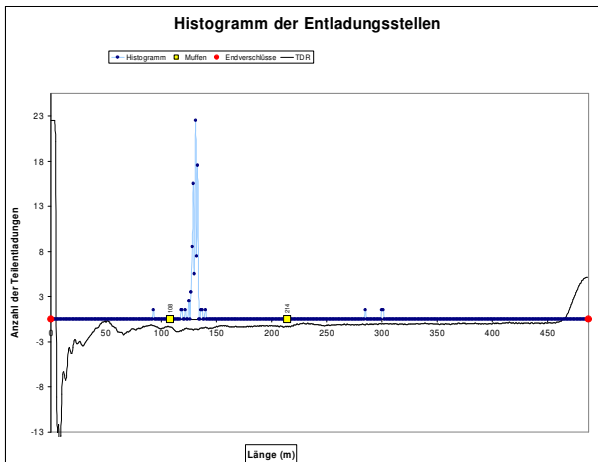
Figure 5: discharges in a limited zone of about 30 metres

During test of a PILC cable in the N-Ergie network, discharges were located in 2 phases in the same zone of about 30 meters of length (see figure 5). The recommendation for action was: replacement of this 30 meters cable section.

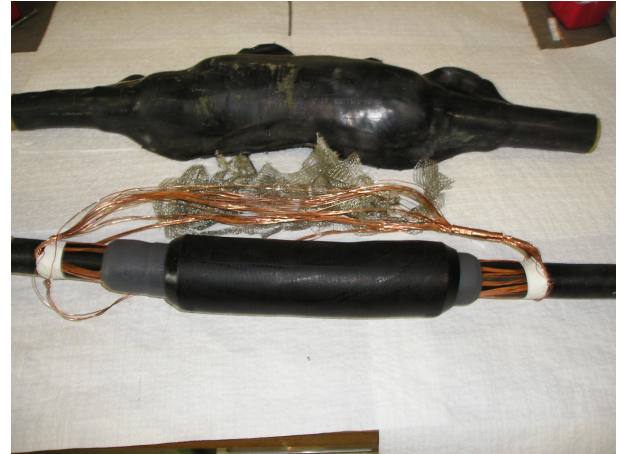
Figure 7: Splice body not correctly positioned

During test in the N-Ergie network, discharges were detected in a splice. Investigation of the splice revealed that the splice had not been installed correctly. (see figure 7)

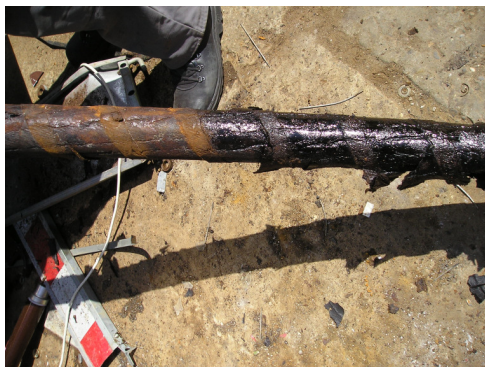
Figure 6 investigation results
Transition dry - wet

After investigation, cracks were found in the lead sheath and the paper was dried out in a limited section of the cable. (see figure 6)

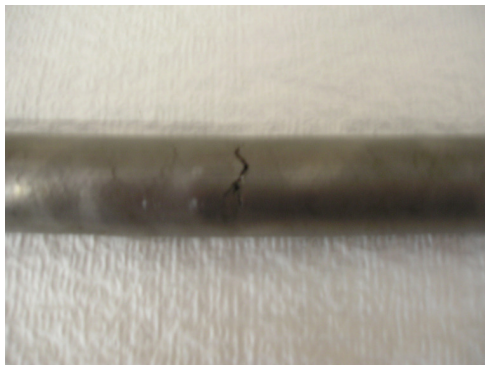
Figure 6: investigation results:
Cracks in the lead sheath
