High safety and low maintenance aerial cable system withstanding extreme weather

Lars EFRAIMSSON, Ingvar HAGMAN, Jan KÖHLER, Håkan BRINGSSELL

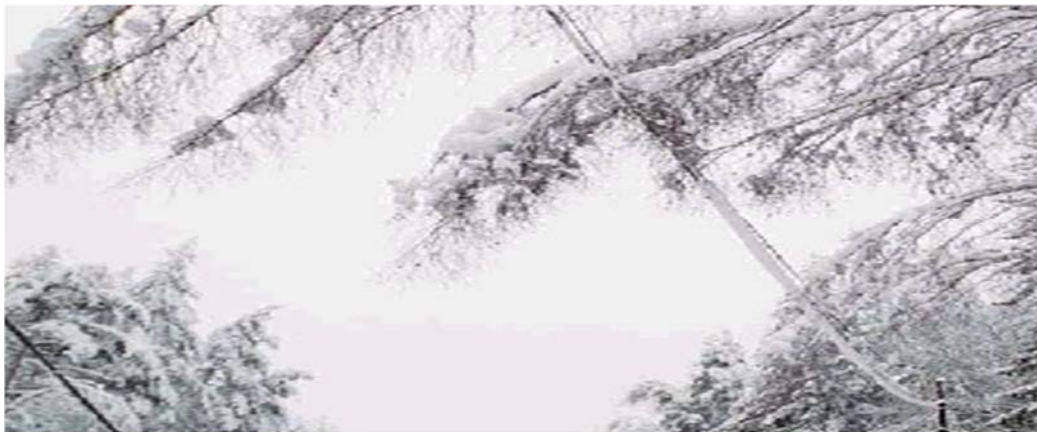
Fig 1 Snow covered heavy branches on live cable

A system has been developed in response to utilities demands to withstand extreme weather conditions without power interruption. The unique design can handle e.g. ice loads, storms and snow-laden trees. The self-supporting conductors take up the bulk of the tensile stress. The forces from a falling tree are propelled through the cable sheath and insulation into the supporting conductor, without damaging the cable. This reduces repair down time in comparison with other systems - resulting in less repair call-outs and smooth maintenance.

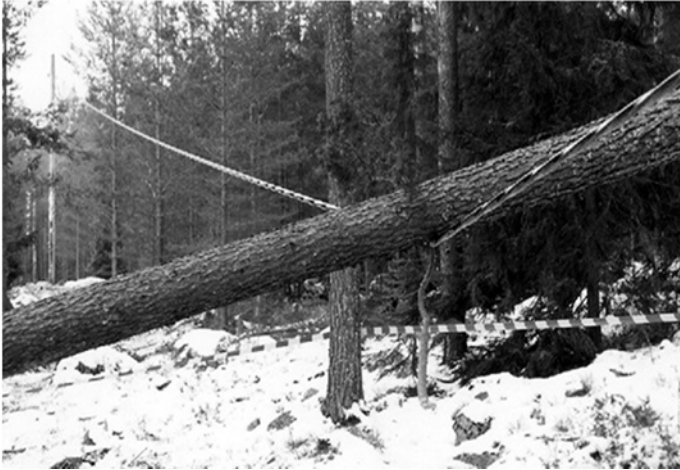
Fig 2 Heavy tree on live cable

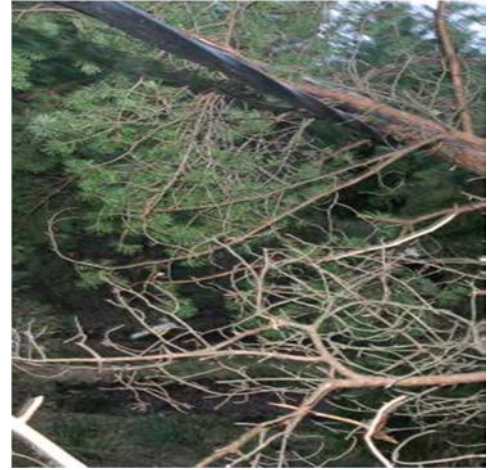
Fig 3 Trees on live cable after storm
