A Study on Partial Discharge and Bubble Behavior in Oil Gap on Oil-impregnated Paper Insulation System.

Yuta **MAKINO**, Takashi **KURIHARA**, Toshihiro **TAKAHASHI**; Central Research Institute of Electric Power Industry (CRIEPI), (Japan), y-makino@criepi.denken.or.jp, ktakashi@criepi.denken.or.jp, toshihiro@criepi.denken.or.jp

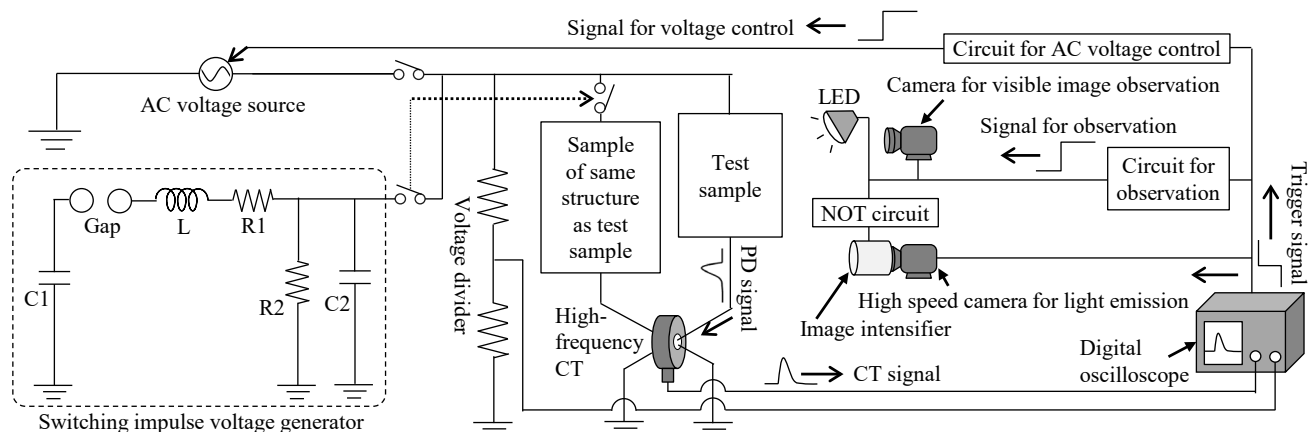
Fig. 1 shows the experimental circuit for observing PD signal, light emission of PD, and visible image under AC and switching impulse voltages application. This is composed of AC voltage source, a switching impulse voltage generator, a voltage divider (Nissin pulse electronics, EP-100K, divider ratio: 5000:1, frequency band: DC~50 MHz), a test sample, a high-frequency CT (HFCT) (Prodyn, I-125-1HF, frequency band: 120 kHz~600 MHz), a digital oscilloscope (Tektronix, DPO3054, frequency band: DC~500 MHz, sampling rate: 2.5 GS/s), a high-speed camera (nac Image Technology, MEMRECAM Q1v, frame rate: 8000 fps, effective pixels: 640×480 pixels), an image intensifier (Hamamatsu Photonics, C6654, luminous gain: 4.0×10^6 (lm/m²)/lx), a camera for visible image observation (Omron Sentech, STC-MCS43U3V (527 fps) at AC voltage application, STC-MCE132U3V (60 fps) at switching impulse voltage application). The values of C1, L1, R1, R2 and C2 on the switching impulse voltage generator are 16.7 nF, 1.8 mH, 20 kΩ, 140 kΩ and 4.3 nF, respectively. HFCT was attached on the ground wire of the test sample. A ground wire of the sample of the same structure as the test sample was passed through the same HFCT but in the opposite direction, in order to cancel a charging current when a switching impulse voltage was applied to the test sample. Light emission of PD was observed by the high-speed camera combined with the image intensifier.
