Long term stability

New insulating materials for next generation of HVDC cables - methods for evaluation of degradation phenomena by electrical treeing

Stanislaw M. Gubanski

Chalmers University of Technology, Gothenburg Sweden

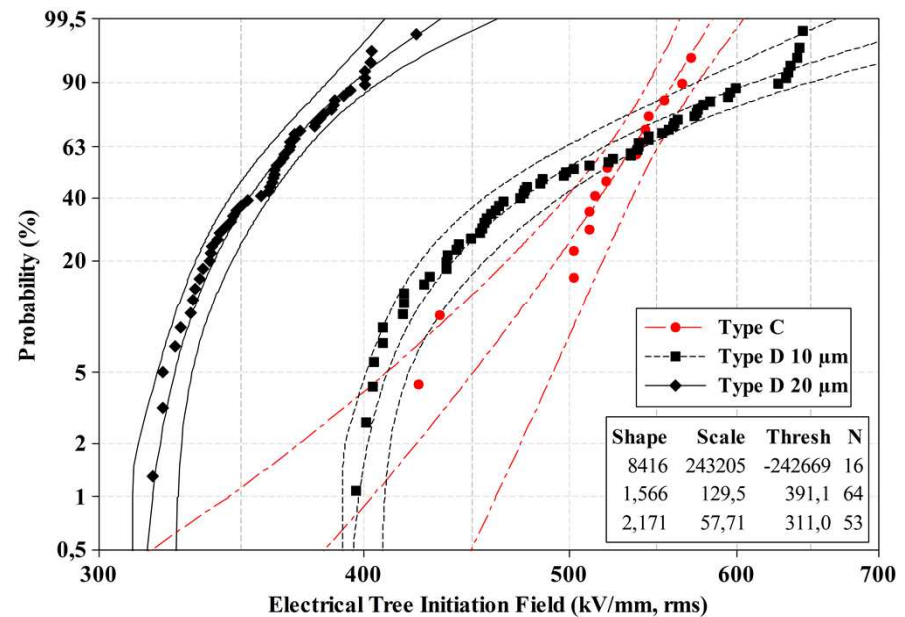
Influence of position on wire - distribution

- samples with 10 and 20 μm wire
- trees growing from defects excluded

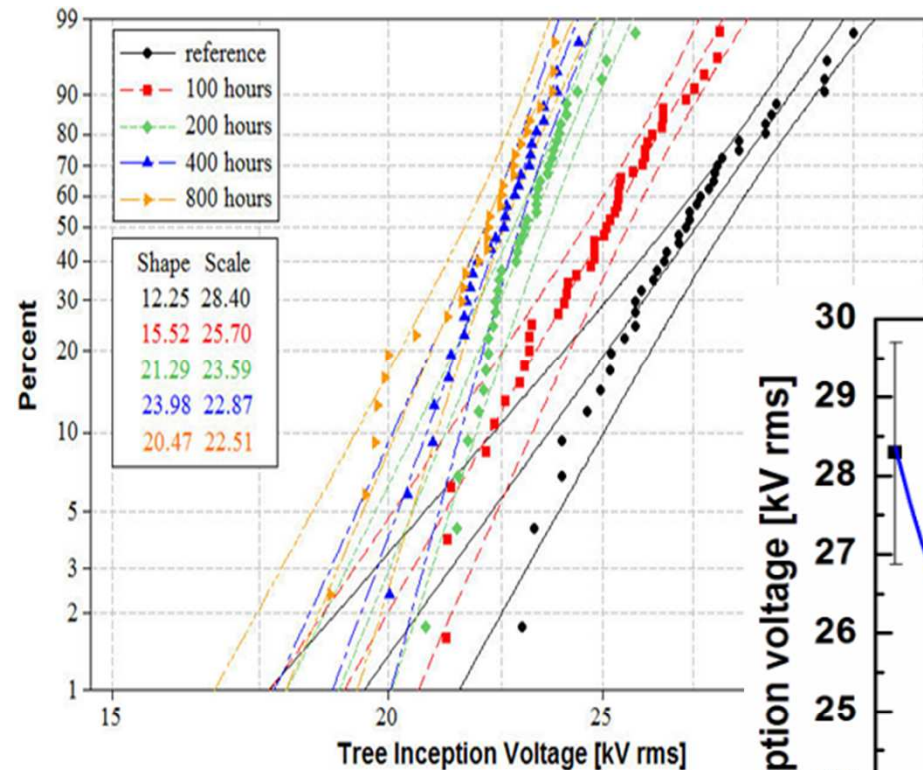
.... and for comparison XLPE material

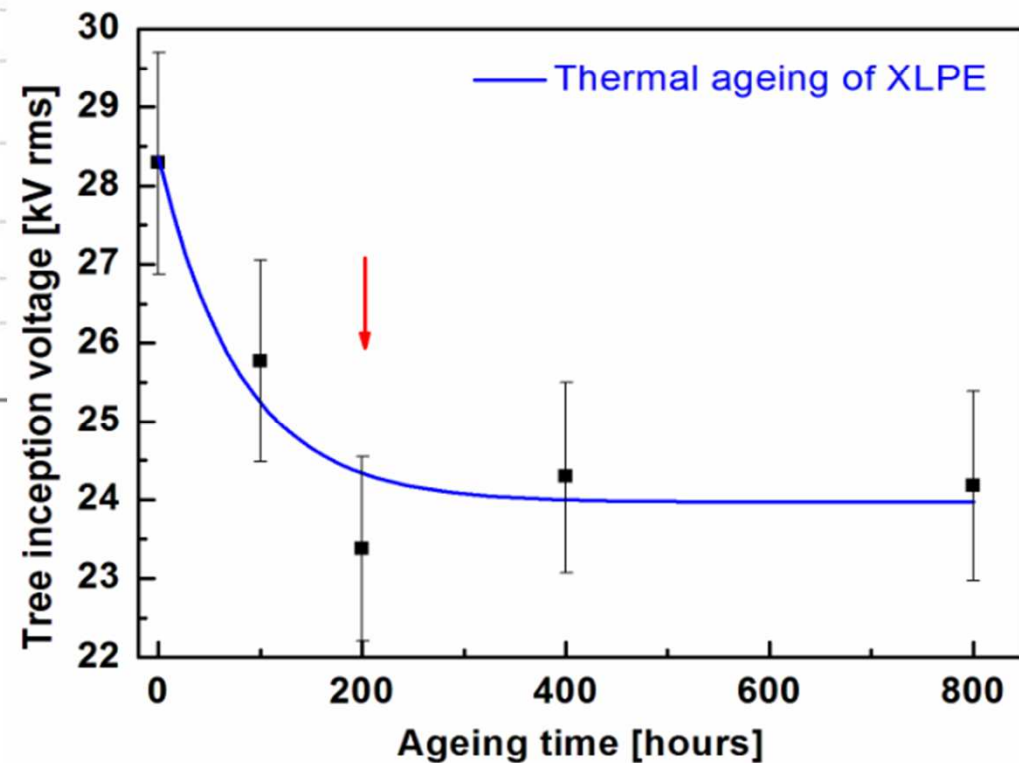
XLPE aged at 80 °C

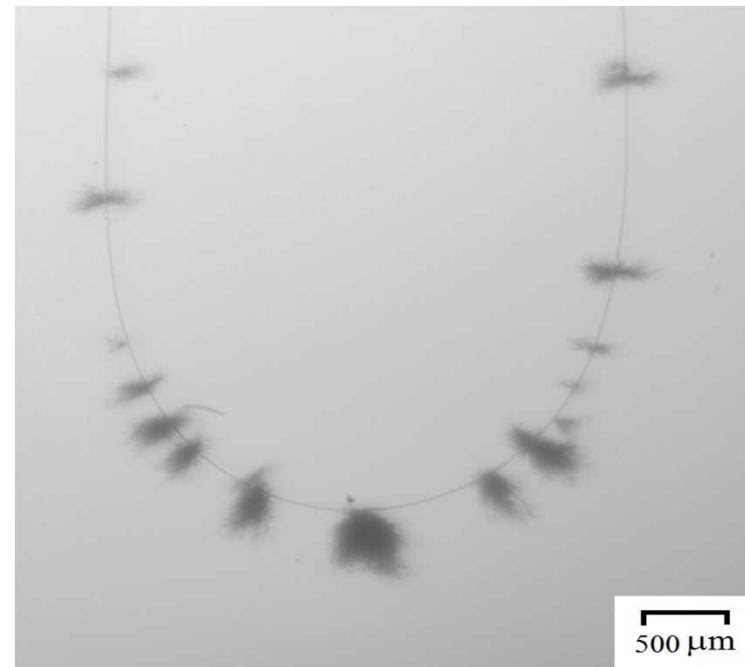
AC trees
