Risk management in the presence of partial discharges in HV joints by means of periodic monitoring

Xabier **BALZA**; Prysmian Group (PG), (Spain) xabier.balza@prysmiangroup.com

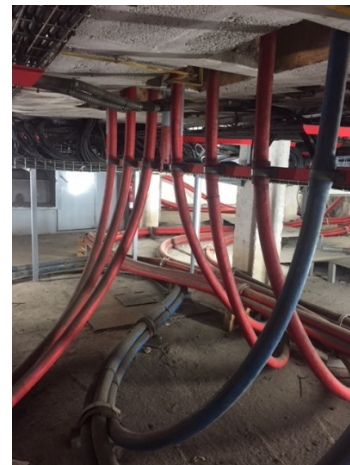
Fig. 1: Substation cable arrangement

The joints were straight joints, and the installation was performed in the basement of a GIS substation, in conditions of very limited space and big density of existing HV cables as can be seen in figure 1.
