## DEVELOPMENT ON THE MORTAR MATERIAL FOR CABLE SYSTEMS IN A DIRECTIONAL DRILLING

Yoshinari NISHIYAMA, Chubu Electric Power Co., Inc. (Japan), Nishiyama.Yoshinari@chuden.co.jp  
Hironori MASHIMA, Chubu Electric Power Co., Inc. (Japan), Mashima.Hironori@chuden.co.jp  
Makoto UESAWA, Chubu Electric Power Co., Inc. (Japan), Uesawa.Makoto@chuden.co.jp  
Hiroshi SAITO, Chubu Electric Power Co., Inc. (Japan), Saitou.Hiroshi2@chuden.co.jp  
Takeshi ISHIZONE, Chubu Electric Power Co., Inc. (Japan), Ishizone.Takeshi@chuden.co.jp  
Satoshi MIZUNO, Toenec Corp. (Japan), satoshi-mizuno02@toenec.co.jp

### ABSTRACT

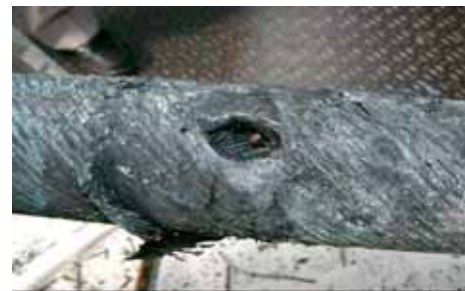
Figure 2: Cable breakdown in a tunnel duct

Cable breakdown has occurred when air mortar is used in conjunction with heavy loaded transmission line (refer to Fig. 2). Estimation of the temperature of the cable using the cable insulator's heat history indicated that abnormal overheating of the cable occurred.

Therefore, the air mortar in the tunnel duct was examined, and the main breakdown area was located in an air gap on the upper side of the tunnel duct. Furthermore, separation of the air mortar material was confirmed. Notably, the air mortar around the cable was dry and brittle and contained plenty of air bubbles. Measurement of the thermal resistance of the air mortar indicated that it was extremely high (about 16 K-m/W) compared with the value of normal soil (about 1 K-m/W). We believe that the high thermal resistance of the air mortar inhibited cable heat dissipation; the cable then overheated, and this resulted in breakdown.

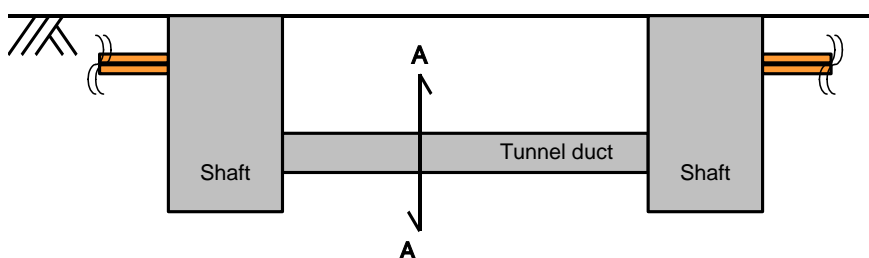
Figure 1: Tunnel duct overview

After the tunnels are run, cable duct is installed and any dead space is filled with infill to produce a tunnel duct (refer to Fig.1).

The main purposes of filling the dead space with infill are to prevent sand from entering the tunnel duct, which would cause a depression in the ground if the tunnel ducts became damaged, and to secure the cable duct in place for cable installation.

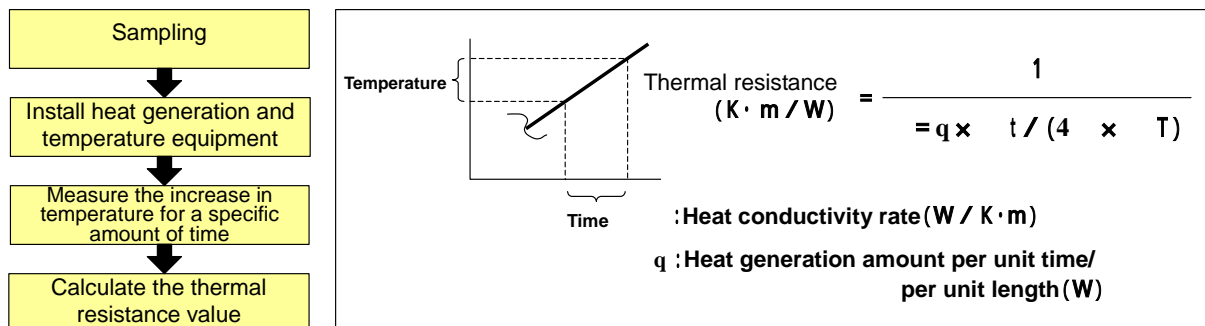
Figure 4: Calculation method for thermal resistance value measurement

The target thermal resistance value was set to be equivalent to that of normal soil (thermal resistance value of 1 K·m/W). Fig. 4 outlines the method used to calculate the thermal resistance value.

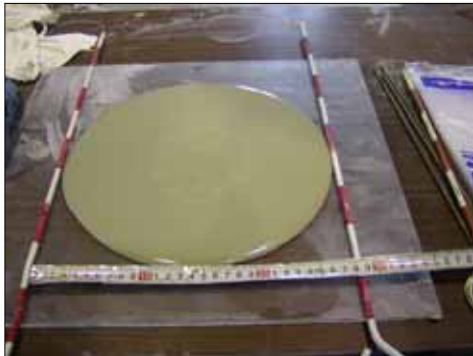
**Figure 5: Flow value measurement conditions**

Therefore, we used a method in which spread (flow value) of the infill on a flat slope was measured as an indicator of the infill’s flow properties (refer to Fig. 5). Taking into consideration that our longest tunnel duct is 400 m and the results of previous measurements of the flow value and pressure feed length, the target flow and pressure feed length values were set to 350 mm or more and 400 m, respectively.

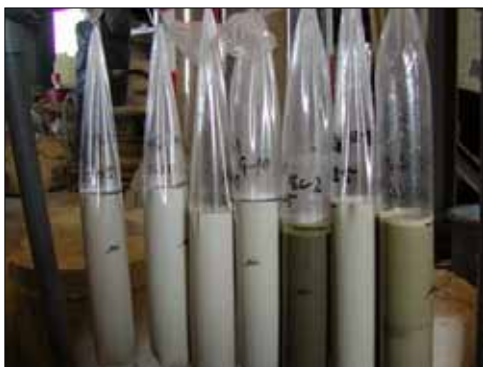
**Figure 6: Breathing rate measurement conditions**

We used the breathing rate, which is a measure of the amount of water after the infill stood still for 24 hours (refer to Fig. 6), to evaluate infill filling ability; the target value for the filling rate was set to 99% or more (breathing rate of 1% or less), taking into consideration the level that does not influence the rise in cable temperature after evaporation of floating water.

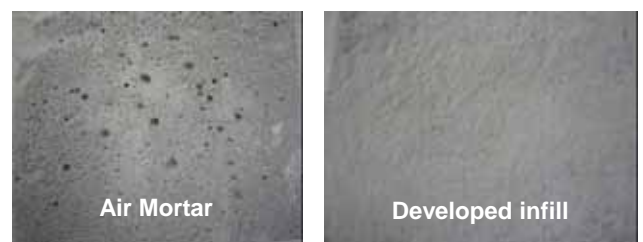
**Figure 7: Comparison of infill surface conditions**

As a result, we were able to develop an infill that is capable of achieving our development goals. A comparison of the currently used air mortar with the newly developed infill is shown in Table 1. Fig. 7 shows a comparison of the surfaces of the air mortar and new infill; it is clear that the new infill has a fine texture and few air bubbles.

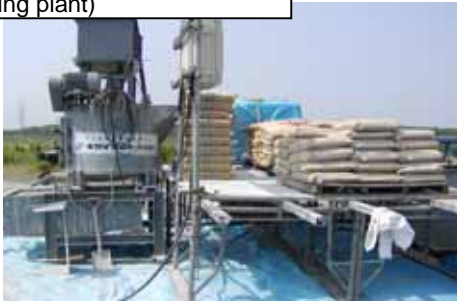
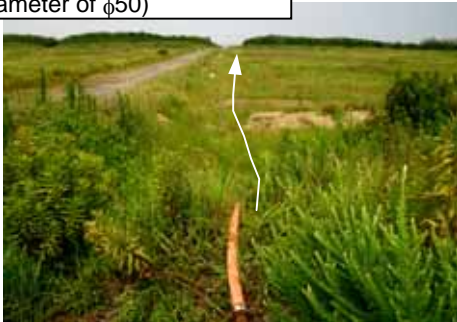
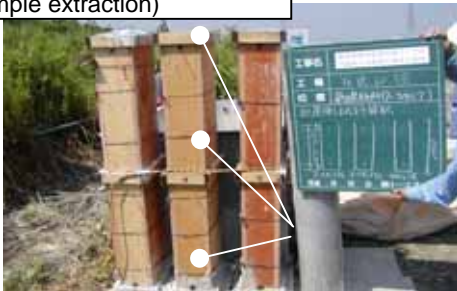
Figure 8: Pressure feed test conditions

New infill was pumped into a 400 m duct ( $\phi 50$  mm duct) from a mixing plant to verify whether or not pressure feed could be conducted.

The flow and breathing values of the new infill were measured before and after it was pumped into the duct. Furthermore, the new infill was enclosed in a 1350-mm-high container, its thermal resistance value was measured, and its separation status was checked at upper, middle, and lower positions (refer to Fig. 8).

Pressure feed start position (mixing plant)

Pressure feed (400 m duct with a diameter of  $\phi 50$ )

Pressure feed end position (sample extraction)

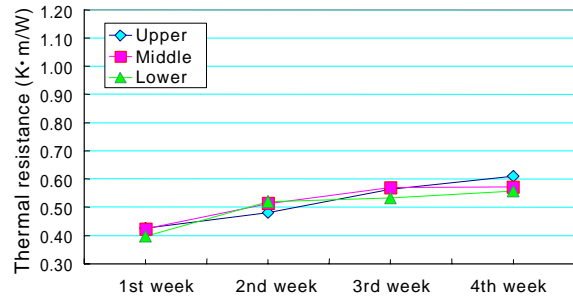
Figure 9: Thermal resistance transition

It was possible to pump the new infill into the 400 m duct, and there appeared to be no change in infill quality after pumping of the new infill was complete. Furthermore, its thermal resistance value was low and stable, and its other basic performance characteristics satisfied our development goals (refer to Table 2 and Fig. 9).

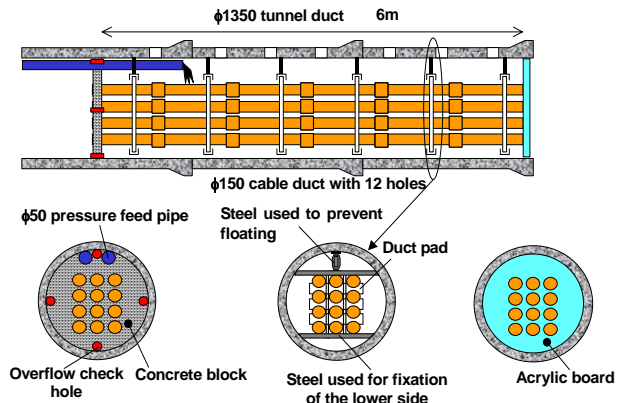
Figure 10: Basic full-scale test diagram

The infill filling status was checked and various other performance characteristics were examined after the infill was pumped into a 6-m-long tunnel duct having a diameter of  $\phi 1350$  mm with 12  $\phi 150$  cable ducts installed (refer to Fig. 10 and 11).

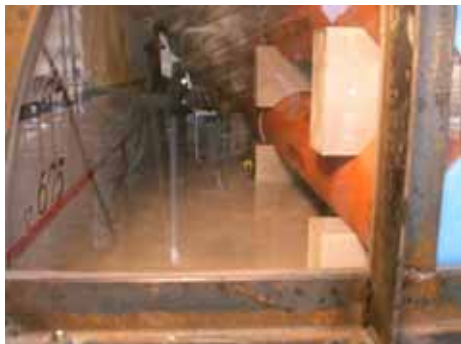
Figure 12: Filling conditions of the full-scale test tunnel duct

We verified that the new infill filled the entire tunnel duct without any gaps because of its extremely high flow ability. Its thermal resistance value and other basic performance characteristics were also good; therefore, use of this new infill is within sight (refer to Fig. 12 and 13).

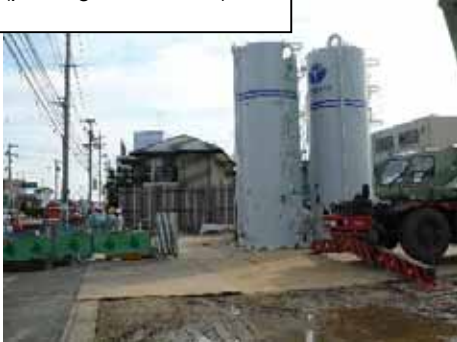
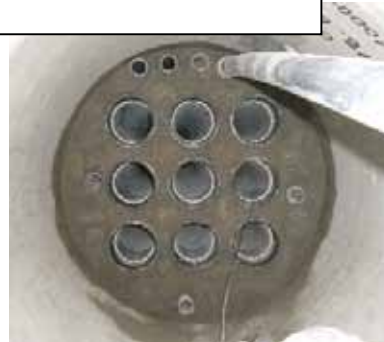
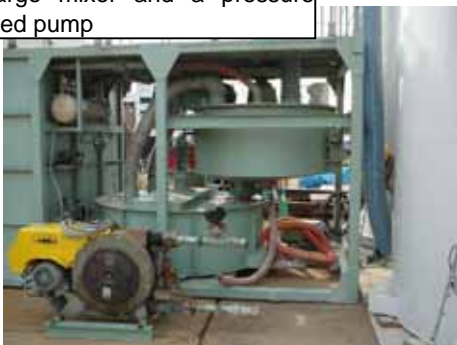
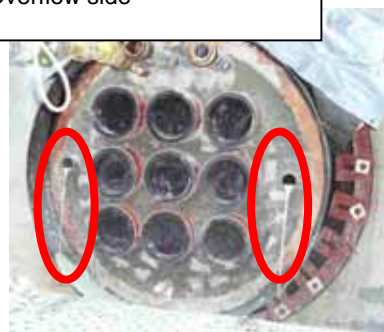
Figure 14: Status during application of infill in the field

Examination of quality and usage in the field using the above control items resulted in good usage characteristics and achievement of the standard values for all basic performance characteristics, indicating that the new infill completely filled in the entire tunnel duct (refer to Fig. 14). We confirmed that the new infill has low thermal resistance by measuring the thermal resistance value of a sample of infill used in the field.

Silo (pouring of materials)

Pressure feed side

Large mixer and a pressure feed pump

Overflow side
