EVALUATION OF THE CONDITION AND THE PERFORMANCE OF UNDERGROUND FLUID FILLED HV LINKS AT HYDRO-QUÉBEC

Christian ROYER, Ray AWAD, Hydro-Québec, (CANADA), royer.christian@hydro.qc.ca, awad.ray@hydro.qc.ca

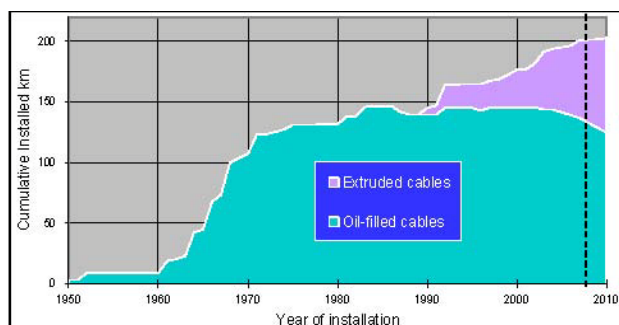
Figure1. Cumulative installed HV underground links at Hydro-Québec (km)

More than seventy (70) of these links, representing 60% of the network in length, were installed in the sixties and the seventies, using Fluid Filled Cables installed in duct banks and manholes. Since 1989, all new links are built using XLPE insulated cables and pre moulded accessories.

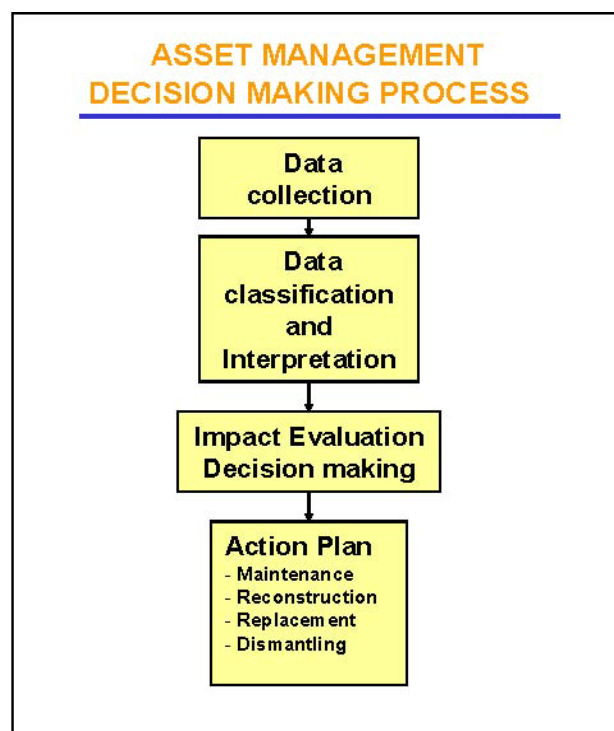
Figure 2. Asset management simplified process

The asset management process can be described by the following four steps, as illustrated in figure 2.

- Step 1. Data collection. This includes all existing data, available from records, and operational data that are collected mainly by maintenance crews. In order to collect useful data, one must have a very good knowledge of the links to be evaluated.
- Step 2. Data classification and interpretation. This step consists of the organisation of data to filter out the most useful information from all the available data.
- Step 3. Impact evaluation and decision making. The evaluation of a link should take into account not only the available data, but also other factors like the strategic importance of a link. Each decision should be made taking into account its global impact on the system.
- Step 4. Action plan. All the decisions taken in step 3 will result in a global action plan; that will help achieve the expected goals of reliability of the network.

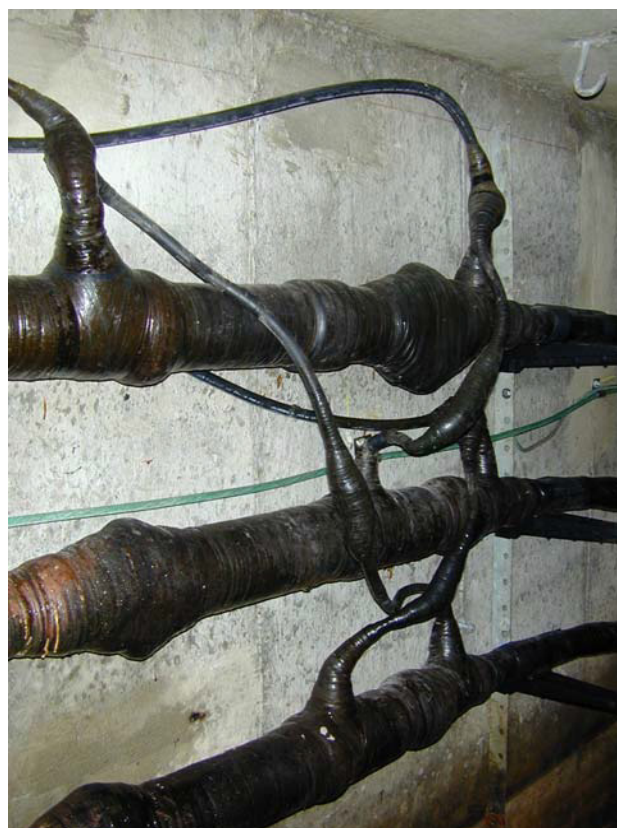
Figure 3. 120 kV sectionalized joints in a manhole

More than 1000 joints are in service at present, ranging from the simple straight-through joints to more complex designs, such as sectionalized joints, oil-feeding joints and oil-stop joints.

In case of sectionalized joints, a fault may be caused by a flashover across the casing insulator, due to excessive transient voltages.

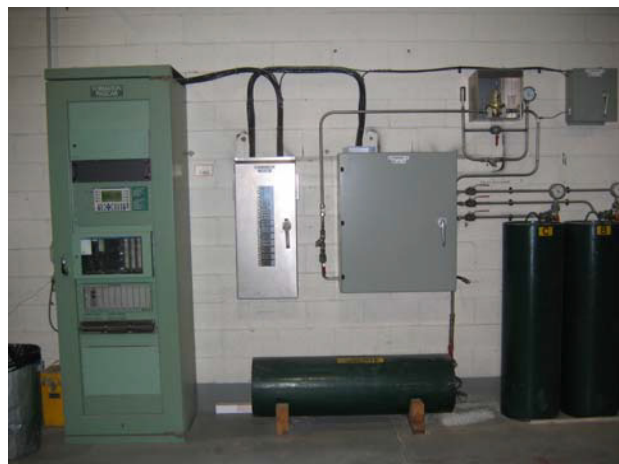
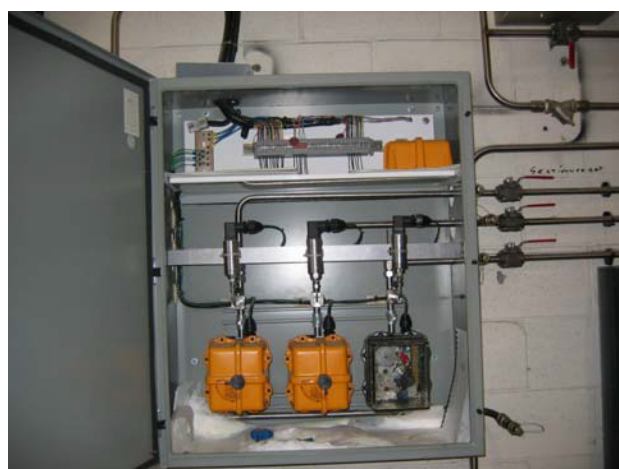
Figure 4. Automated oil pressure monitoring system.

Older systems are fitted with pressure gauges with contacts for alarm relaying. In some cases, the pressures gauges have been replaced by pressures switches and transducers, connected to an electronic monitoring system called **PASCAB**. The new monitoring system greatly increased the reliability and performance of many links by permitting earlier detection of abnormal conditions.

This indicator is related to the presence or absence of the automated oil pressure monitoring system, PASCAB. Long lines and those with multiple hydraulic sections, not equipped with this monitoring system, can be more at risk.

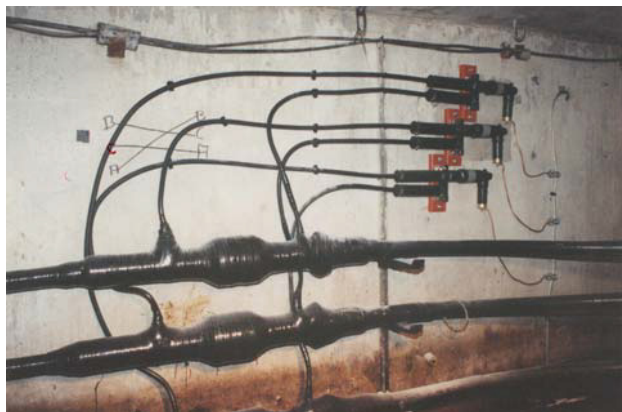
Figure 5 shows an example of cross-bonding in a manhole, using submersible SVL's at the cross-bonding point for sheath protection.

Figure 5. Cross bonding system in a manhole.

Cable sheaths of all our underground links are transposed and well protected with SVL's at the appropriate locations.

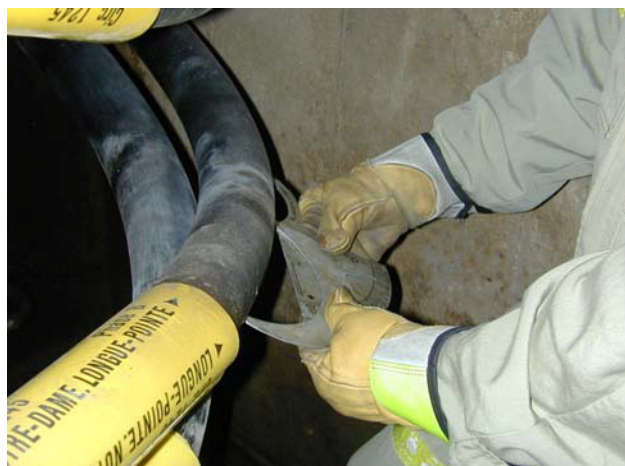
Figure 6: Measuring bending radius during inspection

This indicator is based on the observation of thermo-mechanical movement of cables in manholes. Excessive bending of cables in manhole can lead to oil leaks and eventually insulation failure. In some cases, excessive bending is observed, but the situation has stabilised. Those cases are considered less severe than those where the cable bending radius continues to deteriorate.

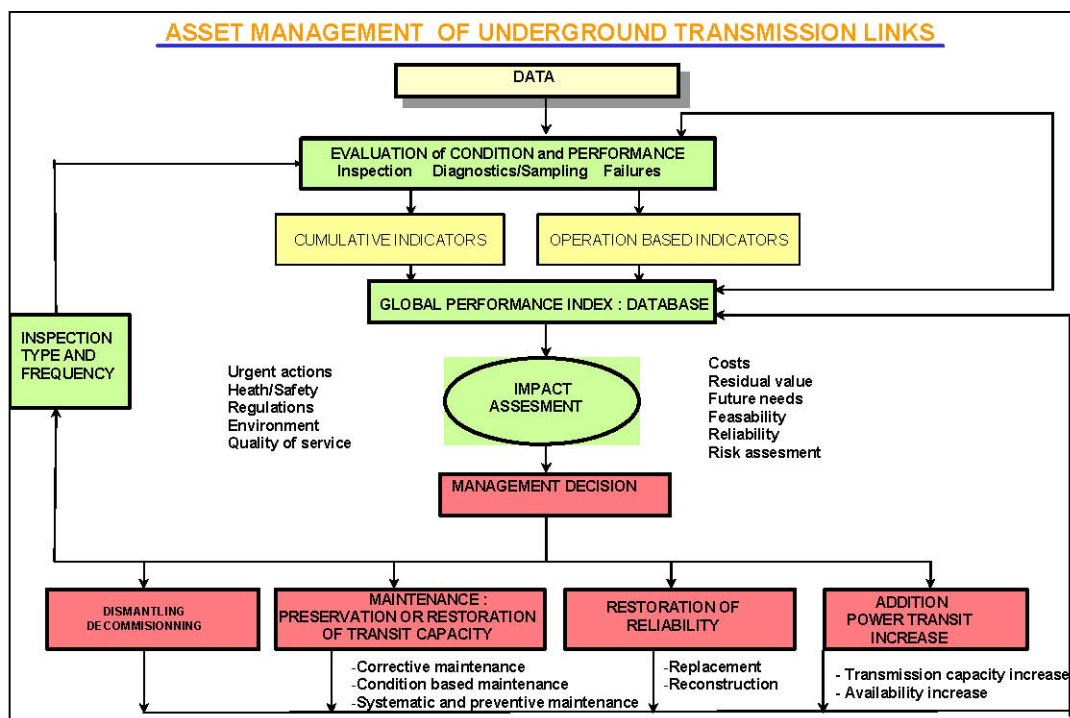
Figure 8: Asset management decision process for HV underground links
