Influence of electrochemical effects on vented tree initiation in accelerated tests

BRÜGGEMANN M., KALKNER W., Technische Universität Berlin, Germany

BROMAN C., SMEDBERG A., Borealis AB, Sweden

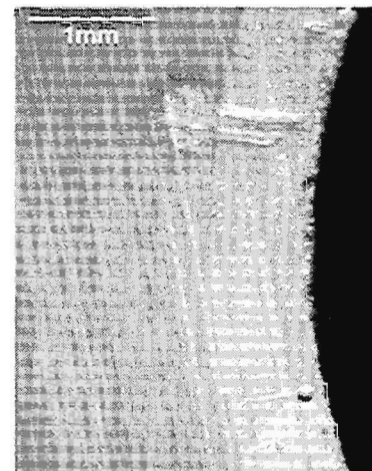
Steinfeld et al. [4] have reported porous channel like structures in the semicon layer initiating relatively large vented trees in the insulation layer, see Figure. 1.

Figure 1. Structures in the inner semiconductive layer of an accelerated wet aged cable.

They proposed that the channels were generated via an electrochemical reaction between the aluminium conductor and the neighbouring semiconductive layer under the influence of mechanical stress. When an electrolyte is present in the conductor area of an insulation system a galvanic cell is formed between
