PARTIAL DISCHARGE DIAGNOSIS ON LIVE EHV POWER CABLE USING PLANAR UWB ANTENNA

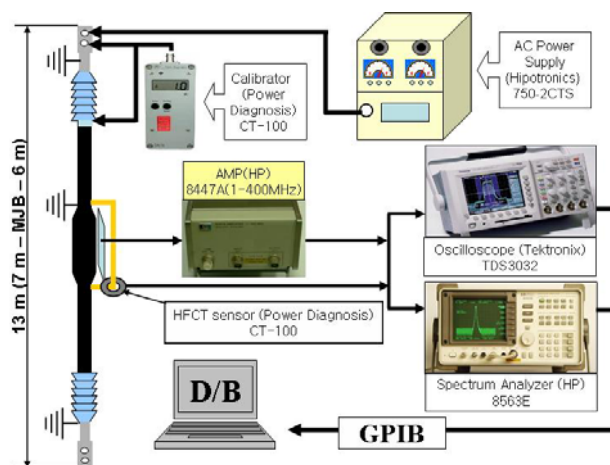
Figure 2: Test Map for Partial Discharge Detection

The measurement system is as shown in Fig 2. We used 20dB amplifier which operates at the frequency range of 1 to 400MHz to amplifier. First, we measured the calibration signal of 10pC, 20pC, 50pC, and 100pC increasing step by step compare between the existing HFCT sensors and capacitive patch sensor. Secondly, we measured the PD signal by injection high voltage of 19kV.
