A novel cooling solution for an intersection of a 2x2 duct bank with HV cables crossed by a steam pipe

ABSTRACT

This paper presents the results of ampacity studies and proposes remedial actions for the situation where a steam pipe and several distribution cable circuits cross a duct bank with HV transmission cables. The studies involved application of a new solution of a gravitational water cooling system. The system is described in detail in the paper. Mathematical models for several possible solutions involving gravitational water cooling, taking the crossing geometry into account, were developed. Practical concerns of BC Hydro engineers with respect to safety and public utility regulations as well as to practicability of the proposed solution are also discussed in the paper.

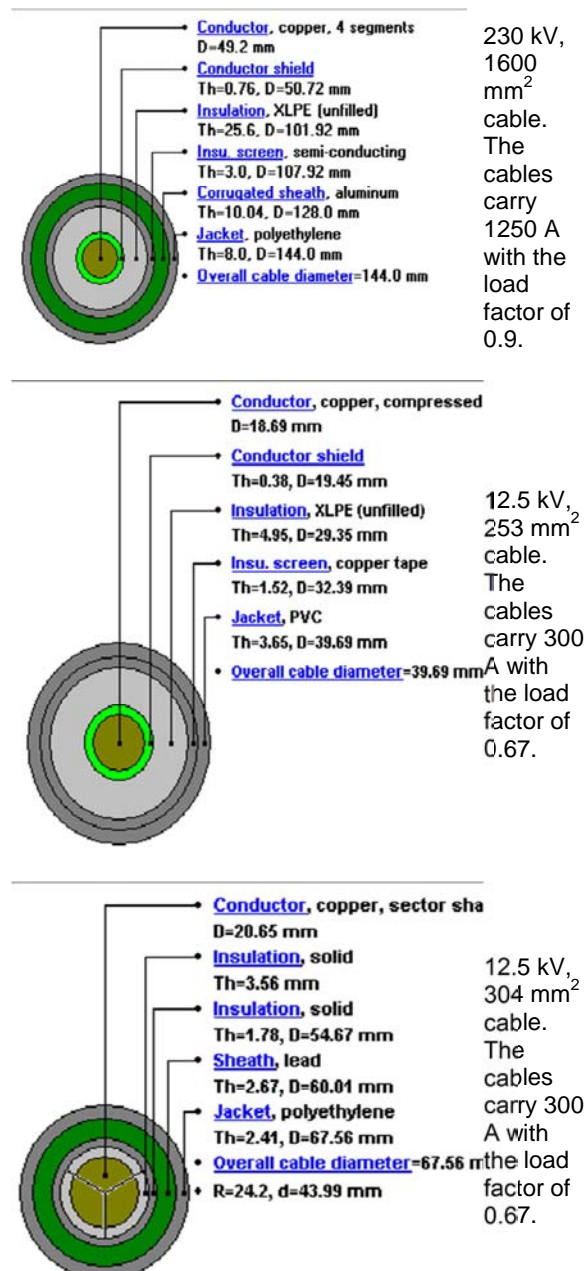
Figure 1 contains information about the 230 kV transmission cables and various distribution cables in this installation.
