## Discovery of a New Degradation Mechanism of Self-Contained Fluid-Filled Cables (SCFF or SCOF) and Development of Diagnostic Technology

*In recent years, some breakdowns of EHV SCOF cables, mainly caused by deterioration at joints and terminations, have occurred in Japan.*

*The cause of these defects is presumed to be partial discharge deterioration due to copper precipitates, and was confirmed by the decomposition investigation of the damaged joint and the like.*

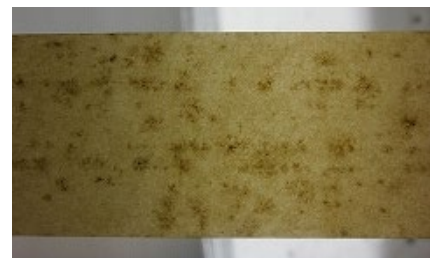
Fig. 2 Black compound on insulation paper

A new degradation mode in SCOF cables has been found in joints in recent years. Black depositions were detected on insulation papers along gaps between rolled papers in dismantling investigations of faulty 275 kV terminations as shown in Fig. 2. Solidified oil combined with oxygen and/or sulfur (hereinafter oxidation sludge), and copper sulfides were detected by EDX, FT-IR, and Raman spectroscopic analysis. In PD tests of insulation paper with black depositions, the PD inception electric field of normal paper was 40 to 50 kV/mm, while that of paper with black depositions was 27 to 40 kV / mm<sup>[2]</sup>.

Focusing on this phenomenon, a new PD deterioration process for SCOF cables, joints and terminations due to dissolved copper compounds in the oil was estimated as shown in Fig. 3, Table.1 and has been verified by various experiments<sup>[3]</sup>.
